TEST REPORT

LOADBEARING WALL

Name of sponsor:	Wood:UpHigh		
Product name:	Loadbearing wall		
File no.:	PGA12247A	Revision no.:	0
Test date:	08/03/2023	Date:	14-07-2023
Pages:	11	Encl.:	55
Ref:	MRD / JBK

EN 1365-1:2012 Fire resistance tests for loadbearing elements Part 1: Walls

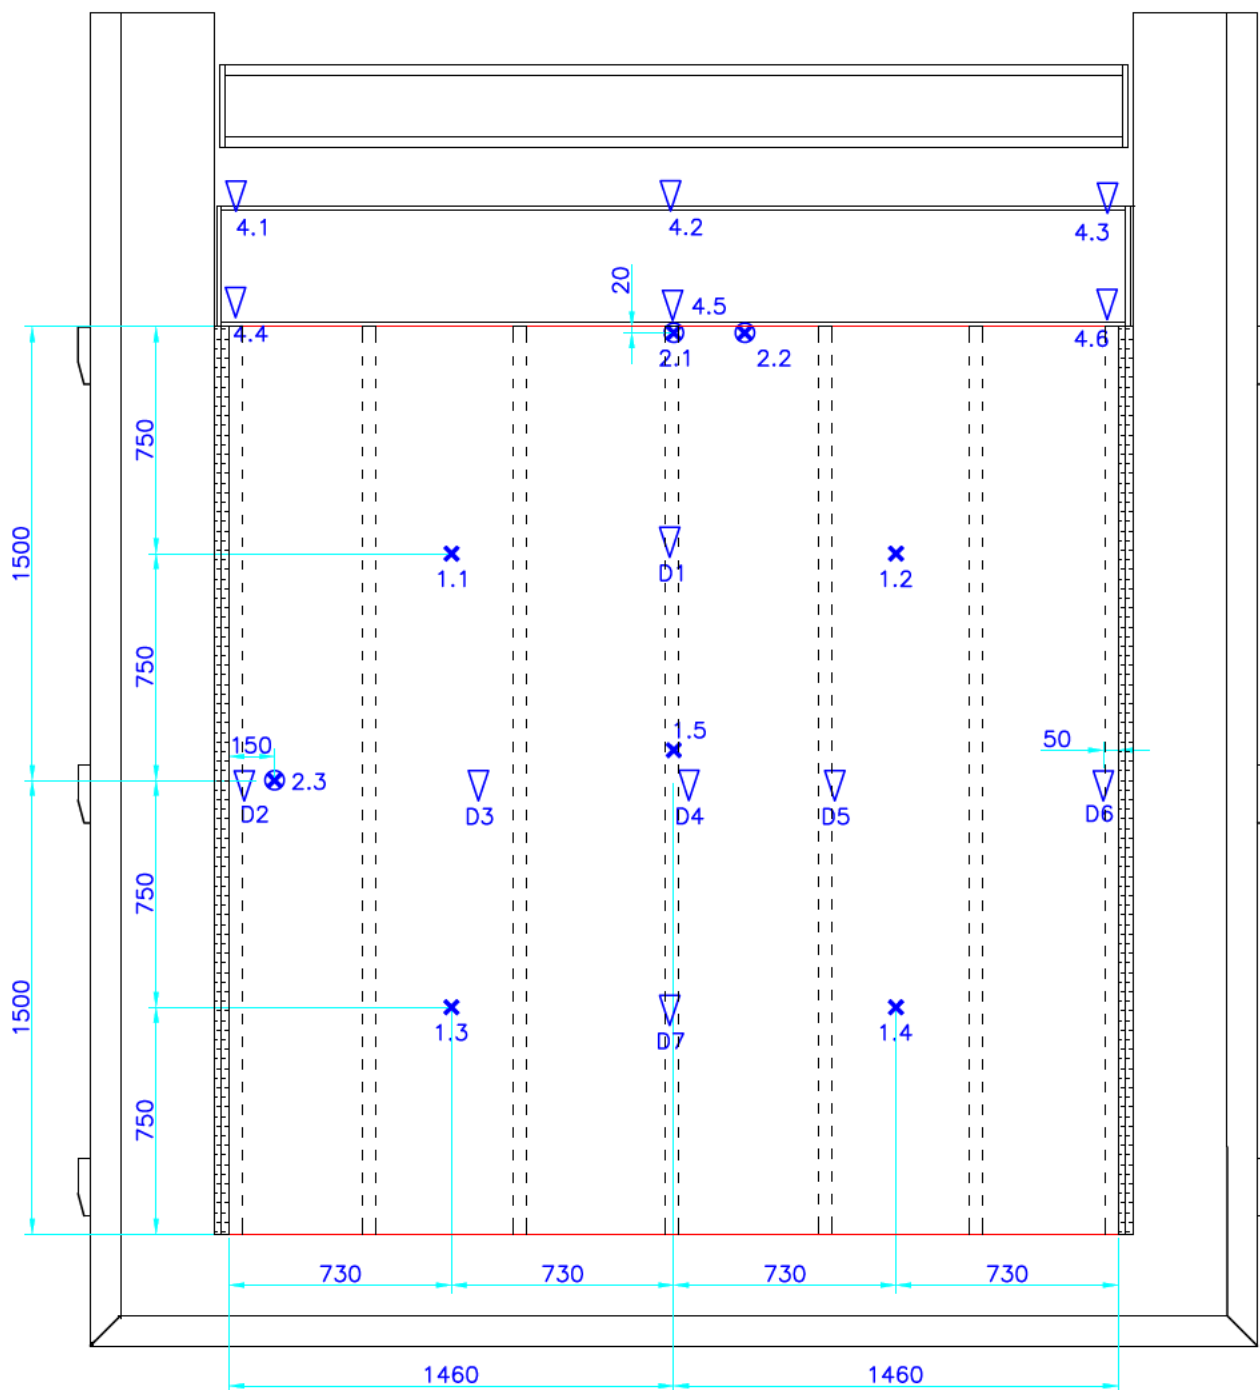
Enclosure: 1.0

- ✕ Thermocouple placed on the unexposed surface (average)
- ⊗ Thermocouple placed on the unexposed surface (maximum)
- ∇ Deflection measuring point

The surface temperatures were measured on the unexposed surface of the test specimen as indicated on DBI drawing no. 1.0.

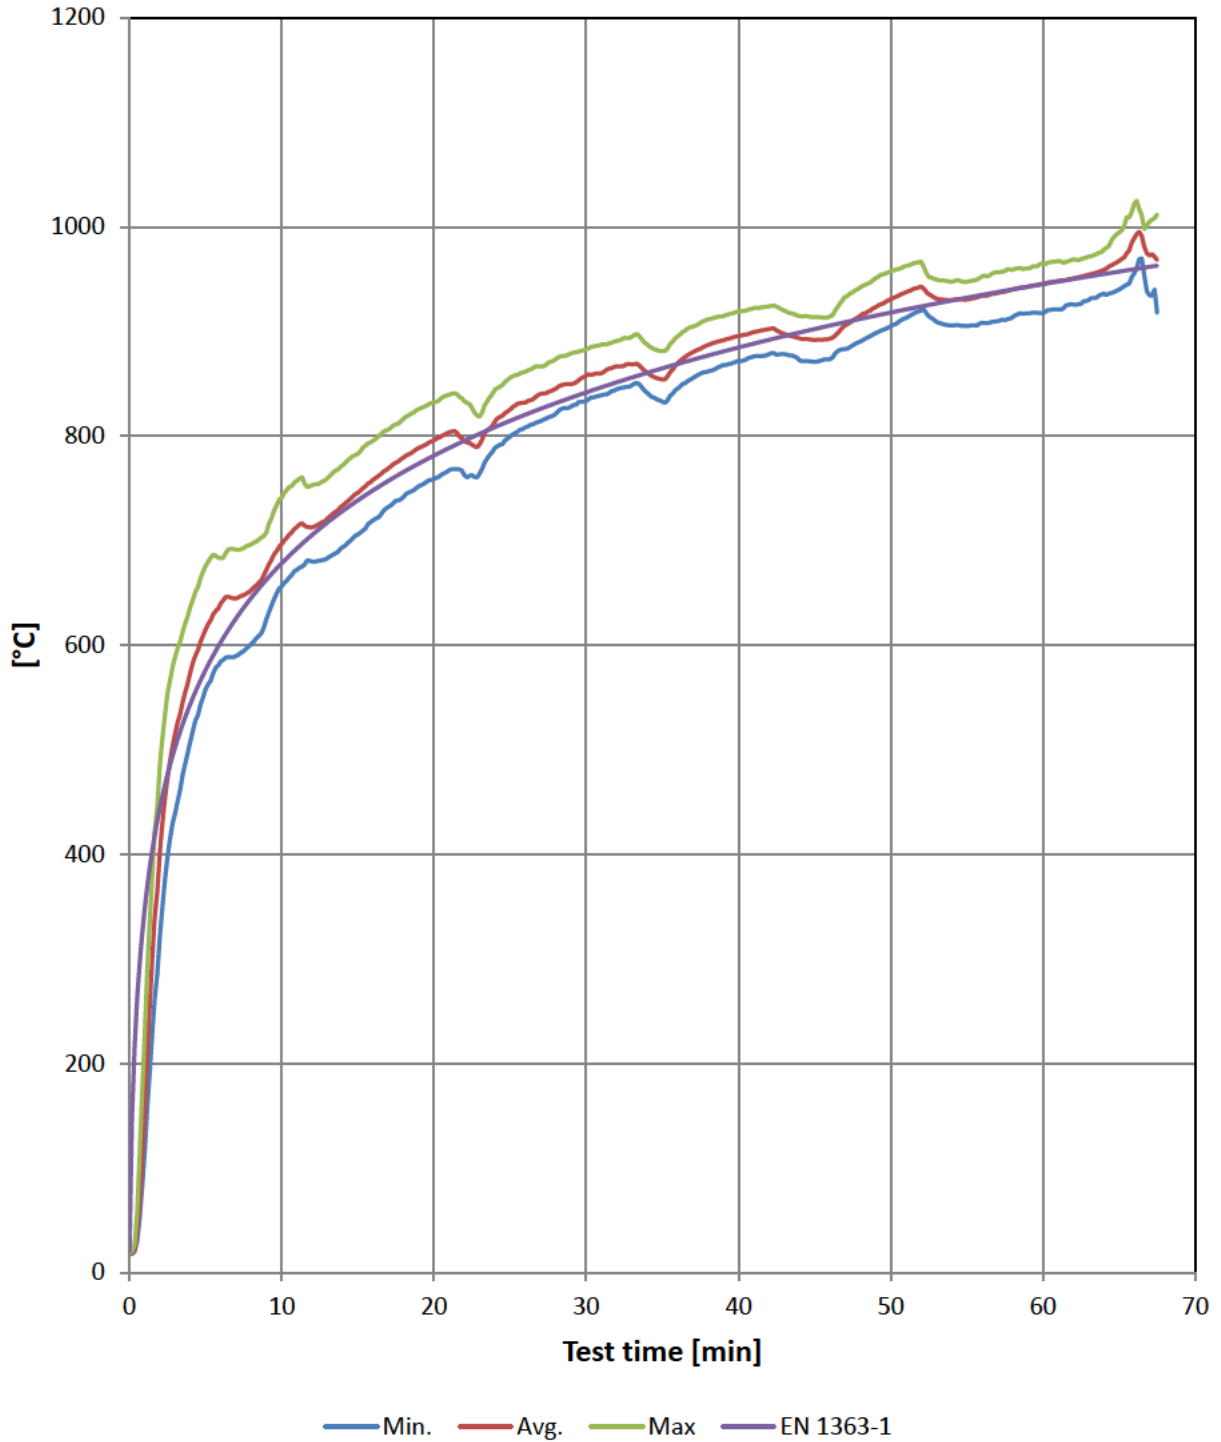
Furnace temperature

The furnace temperature was determined by means of plate thermocouples uniformly distributed at a distance of approximately 100 mm from the exposed side of the test specimen. The furnace temperature was continuously controlled so as to follow the standard time temperature curve within the accuracy specified in EN 1363-1:2020.

Enclosures 2.0 and 2.1	<p>Furnace temperatures</p> <p>The actual minimum-, average- and maximum furnace temperature in relation to the standard temperature. The table also shows the area under the actual time-temperature curve as well as the area under the standard time-temperature curve</p>
Enclosures 3.0 and 3.1	<p>Vertical furnace pressure</p> <p>The differential pressure in the furnace during the test, measured 1,16 m above notional floor level</p>
Enclosures 4.0 and 4.1	<p>Ambient temperature</p> <p>The ambient temperature in the laboratory during the test</p>
Enclosures 5.0 and 5.1	<p>Average temperature rise</p> <p>Measured with 5 thermocouples on the unexposed side</p>
Enclosures 6.0 and 6.1	<p>Maximum temperature rise</p> <p>Maximum temperatures on the unexposed side</p>
Enclosures 7.0 and 7.1	<p>Load per cylinder</p> <p>Load per cylinder during test</p>
Enclosures 8.0 and 8.1	<p>Internal temperature - between clay boards</p> <p>Placed on center board 250 mm from the edge at each side at mid height</p>

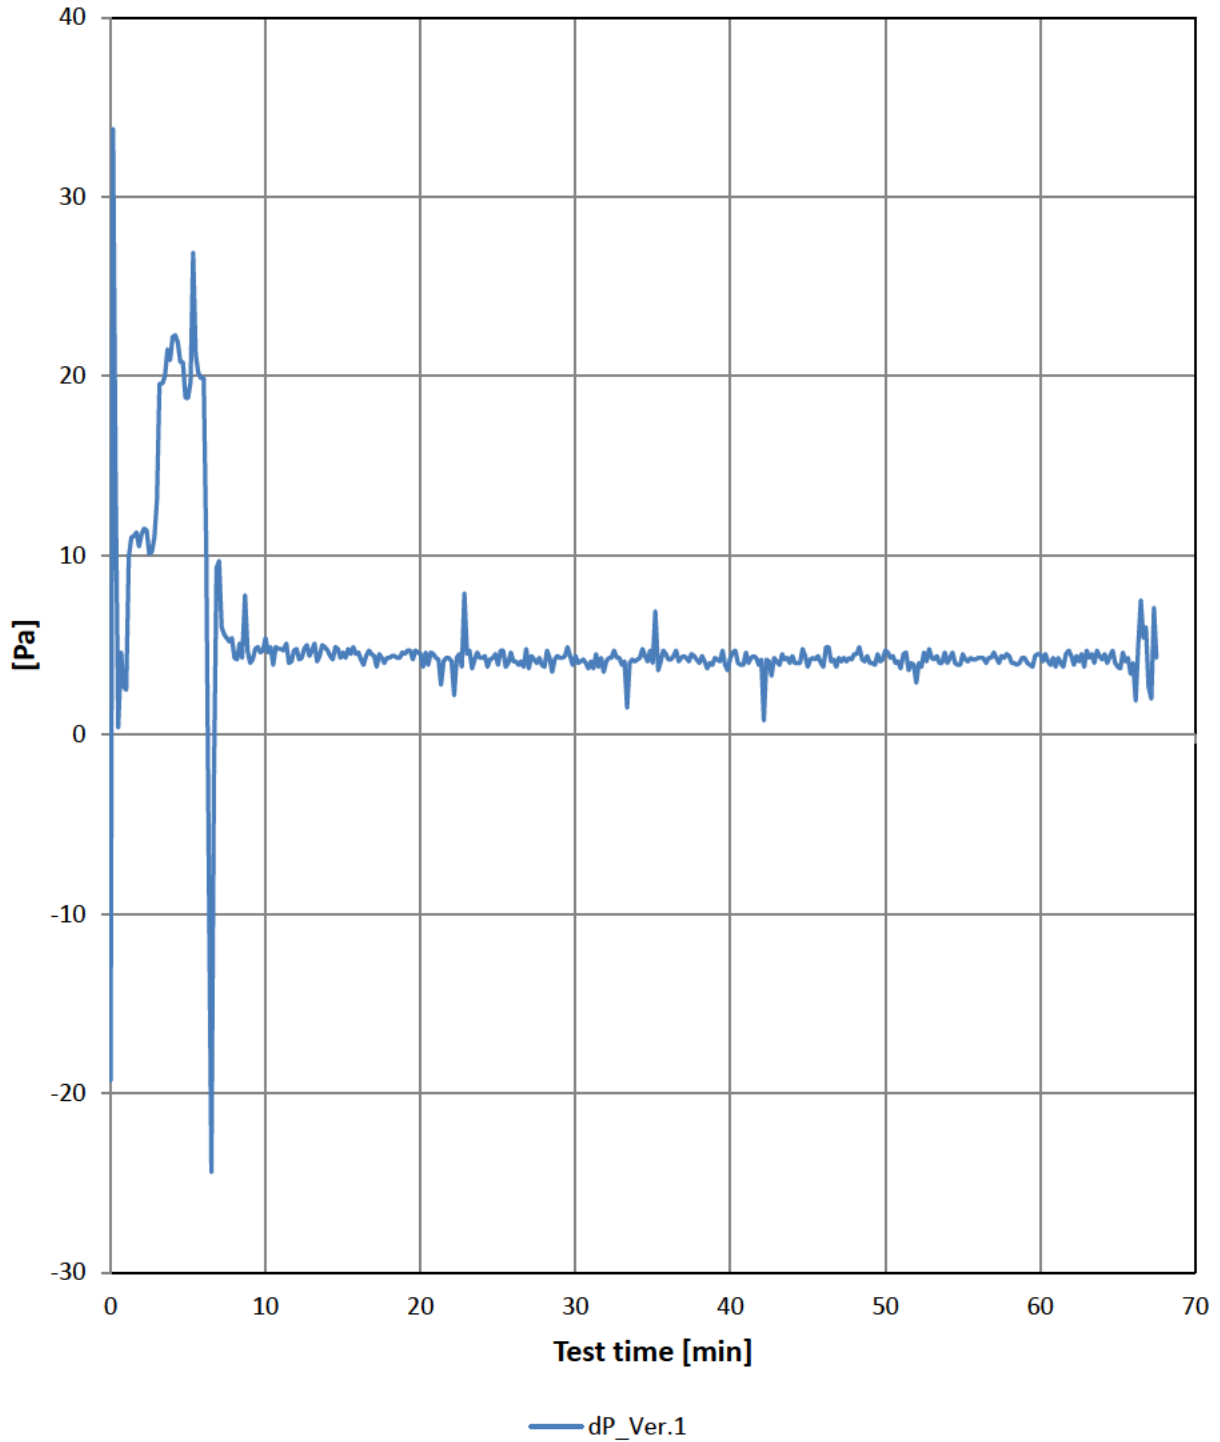
Vertical furnace pressure

The differential pressure in the furnace during the test, measured 1,16 m above notional floor level

The pressure was controlled to maintain 20 Pa at the top of the test specimen.

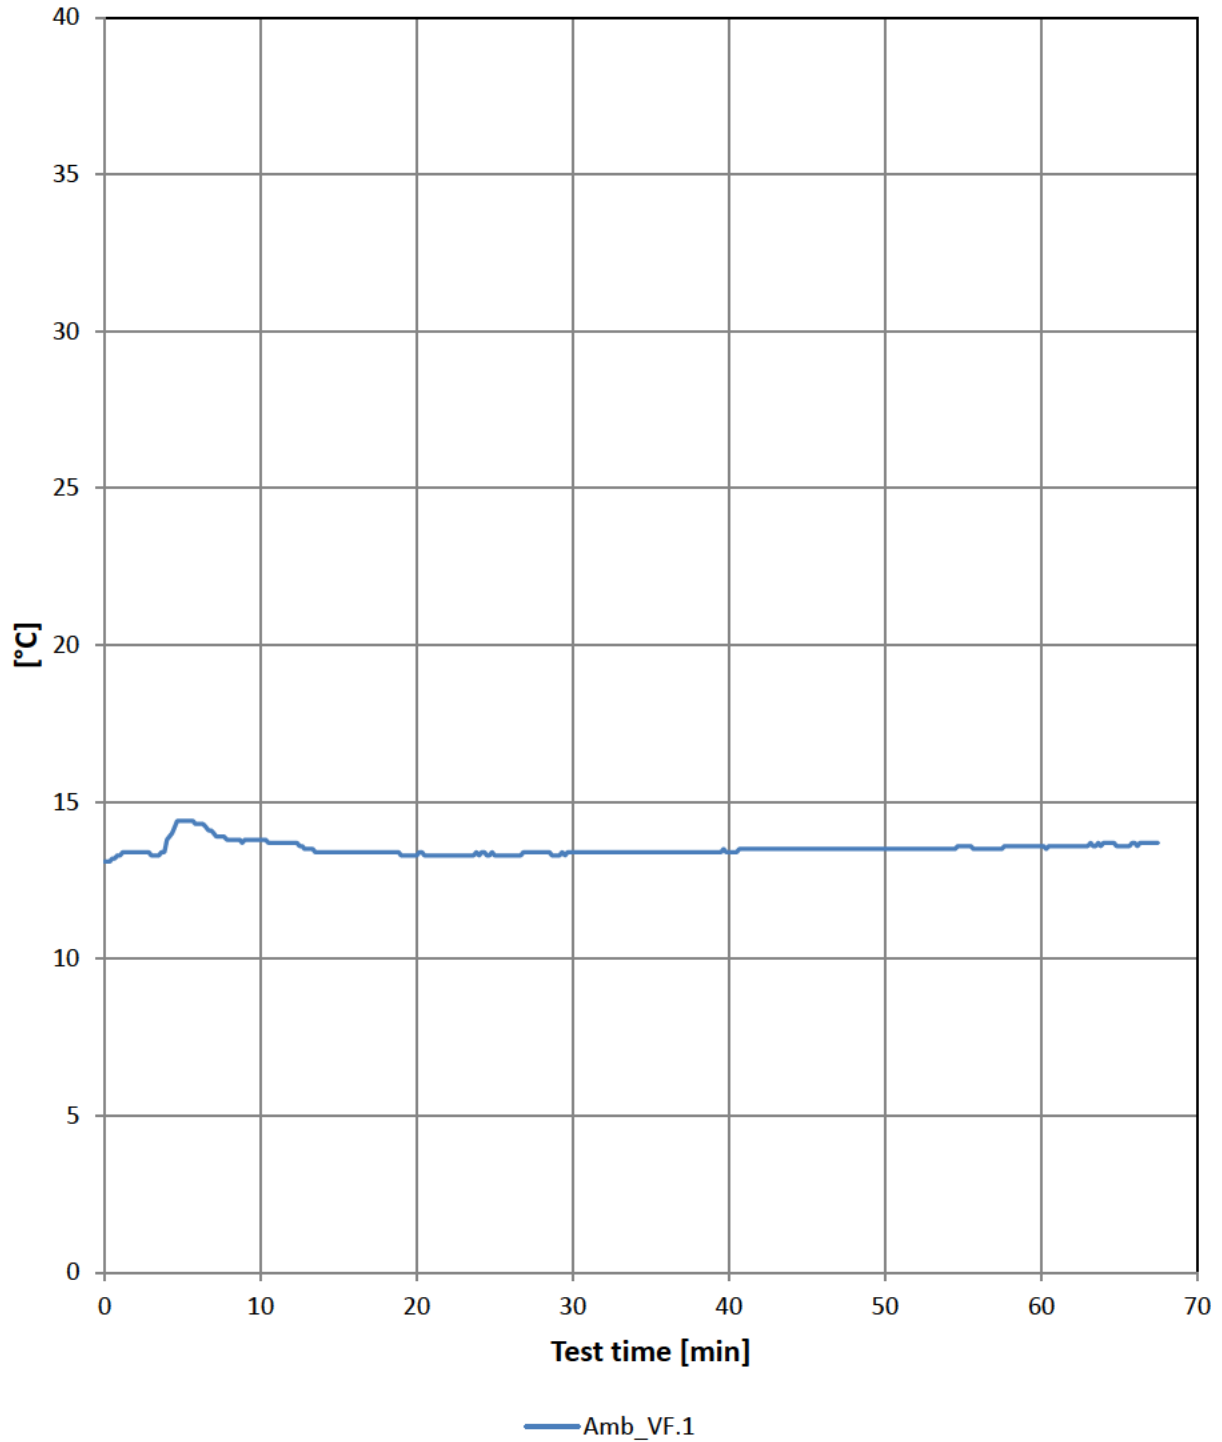
Ambient temperature

The ambient temperature in the laboratory during the test

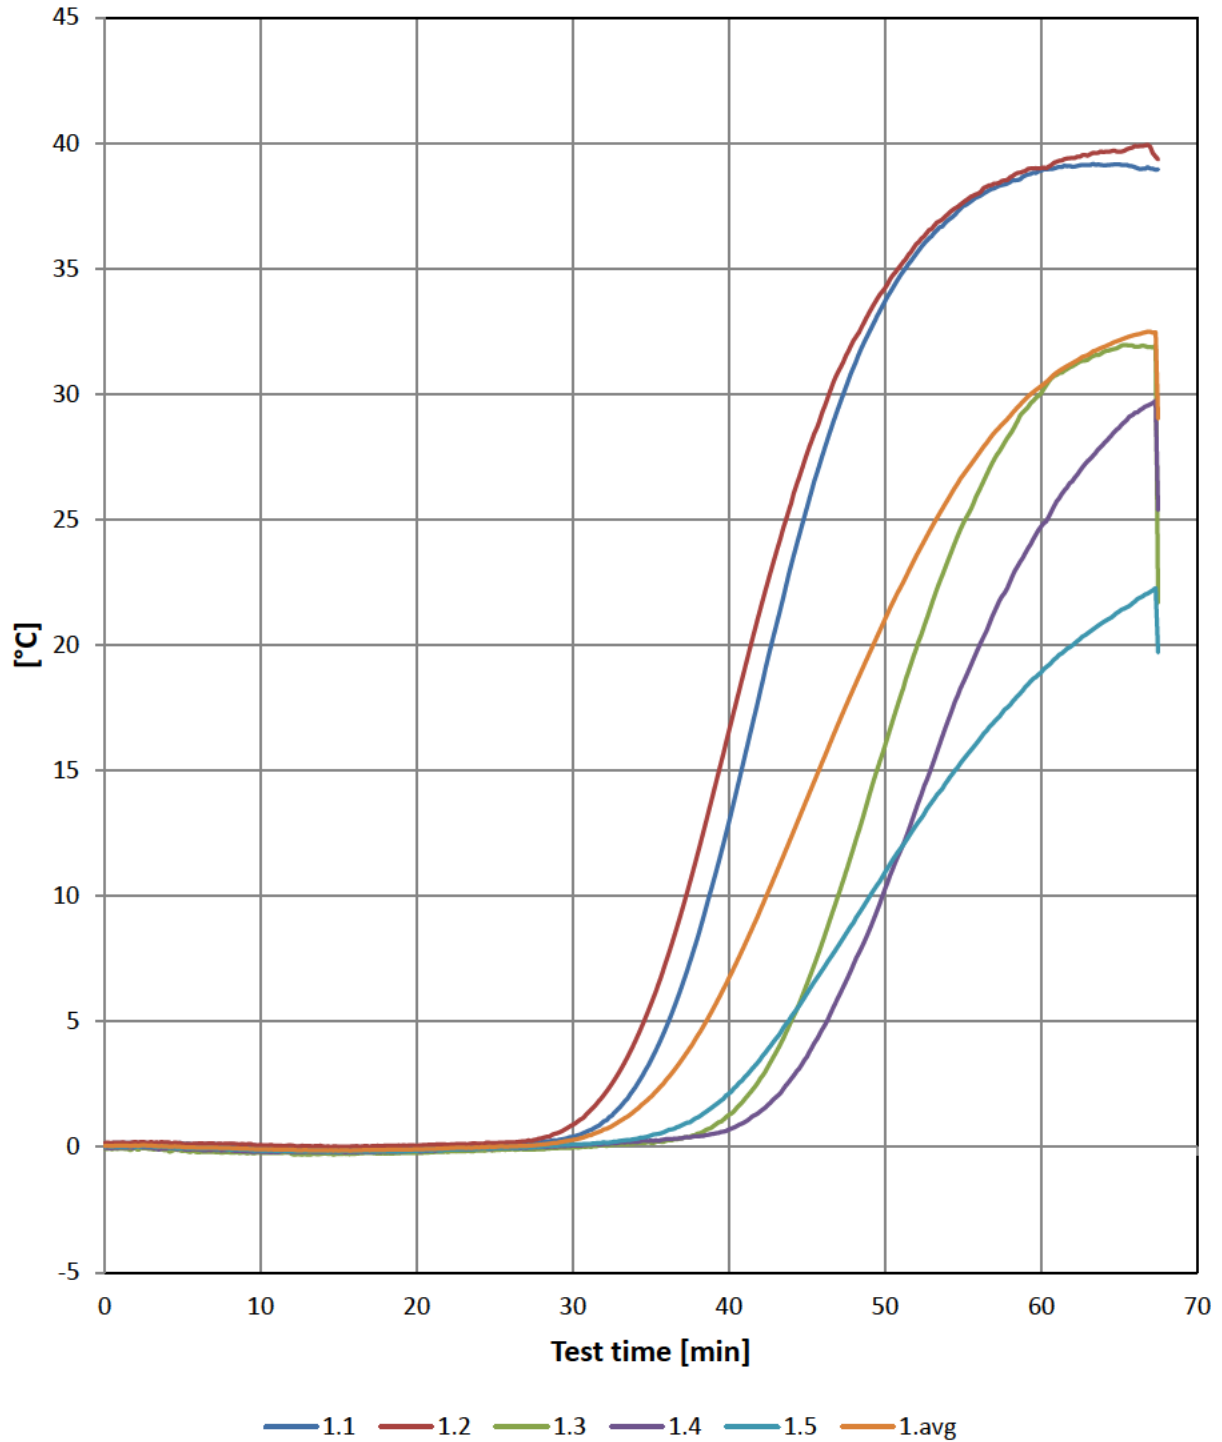
Average temperature rise

Measured with 5 thermocouples on the unexposed side

- Failure of insulation occurred after 66 minutes of testing due to failure of load-bearing capacity.
- The average temperature rise on the unexposed surface of the test specimen did not exceed 140°C during the test.
- The maximum temperature rise on the unexposed surface of the test specimen did not exceed 180°C during the test.

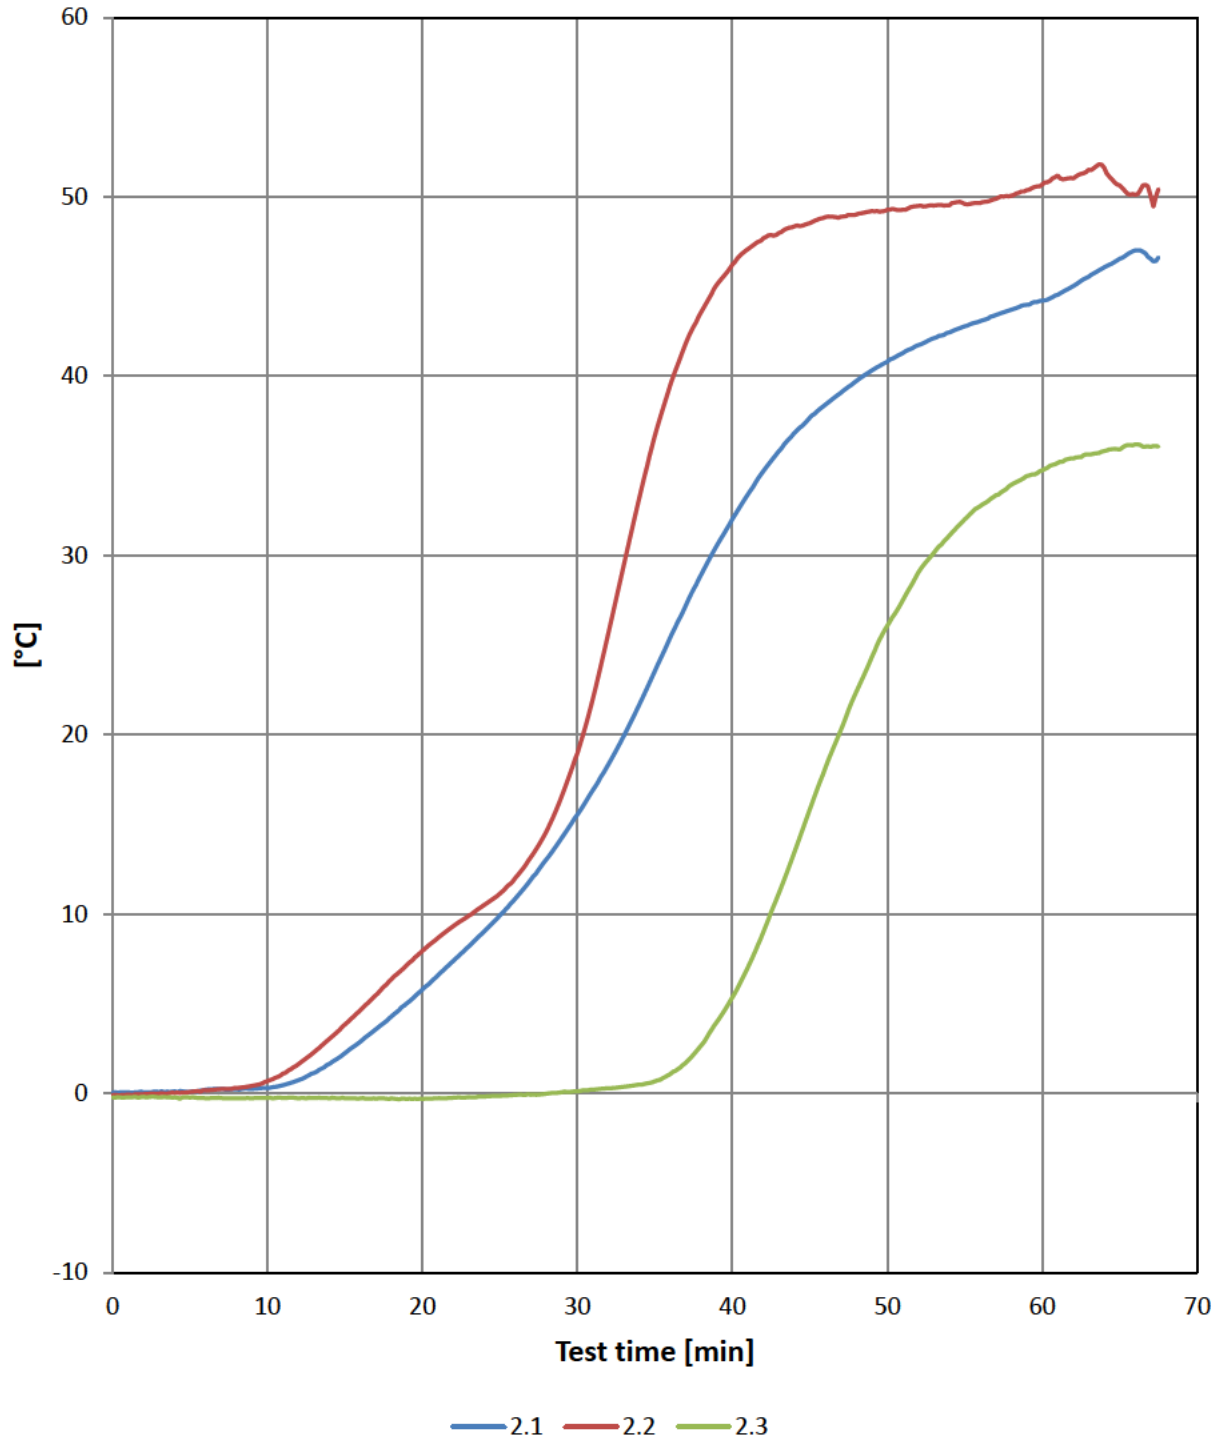
Maximum temperature rise

Maximum temperatures on the unexposed side

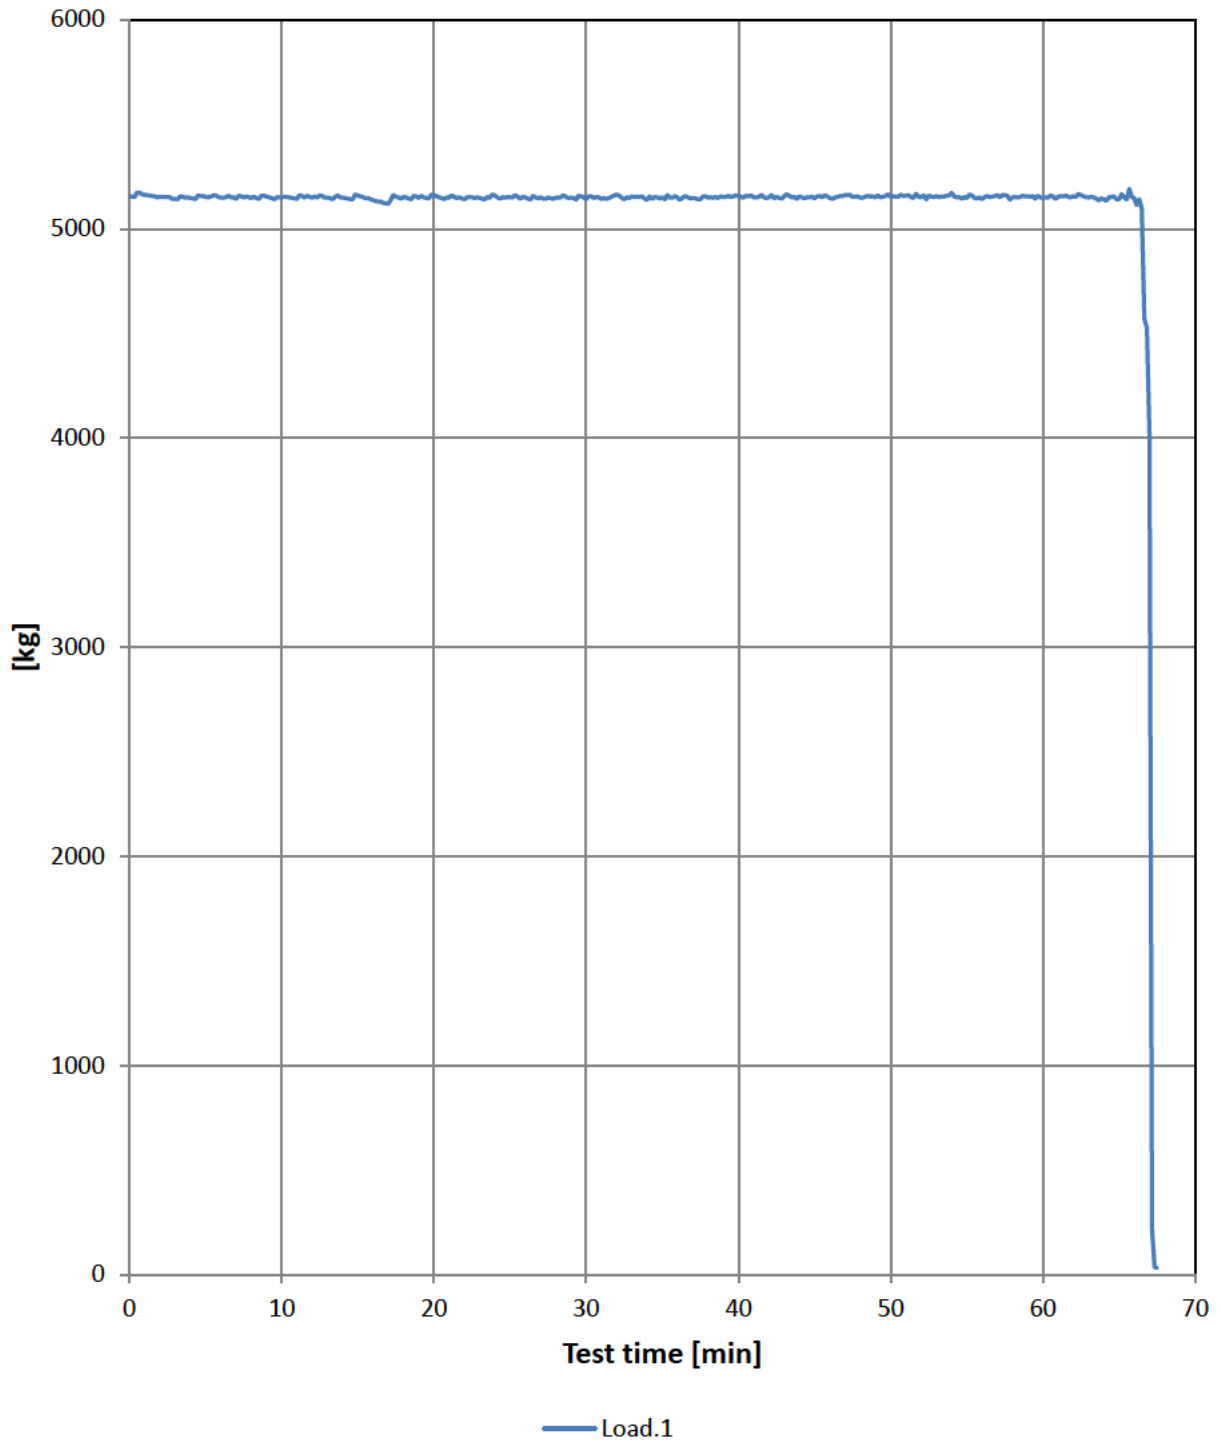
Load per cylinder

Load per cylinder during test

The test specimen was loaded with a total applied load of 37,54 kN/m during the test, corresponding to a total load of 11208 kg or 110,0 kN.

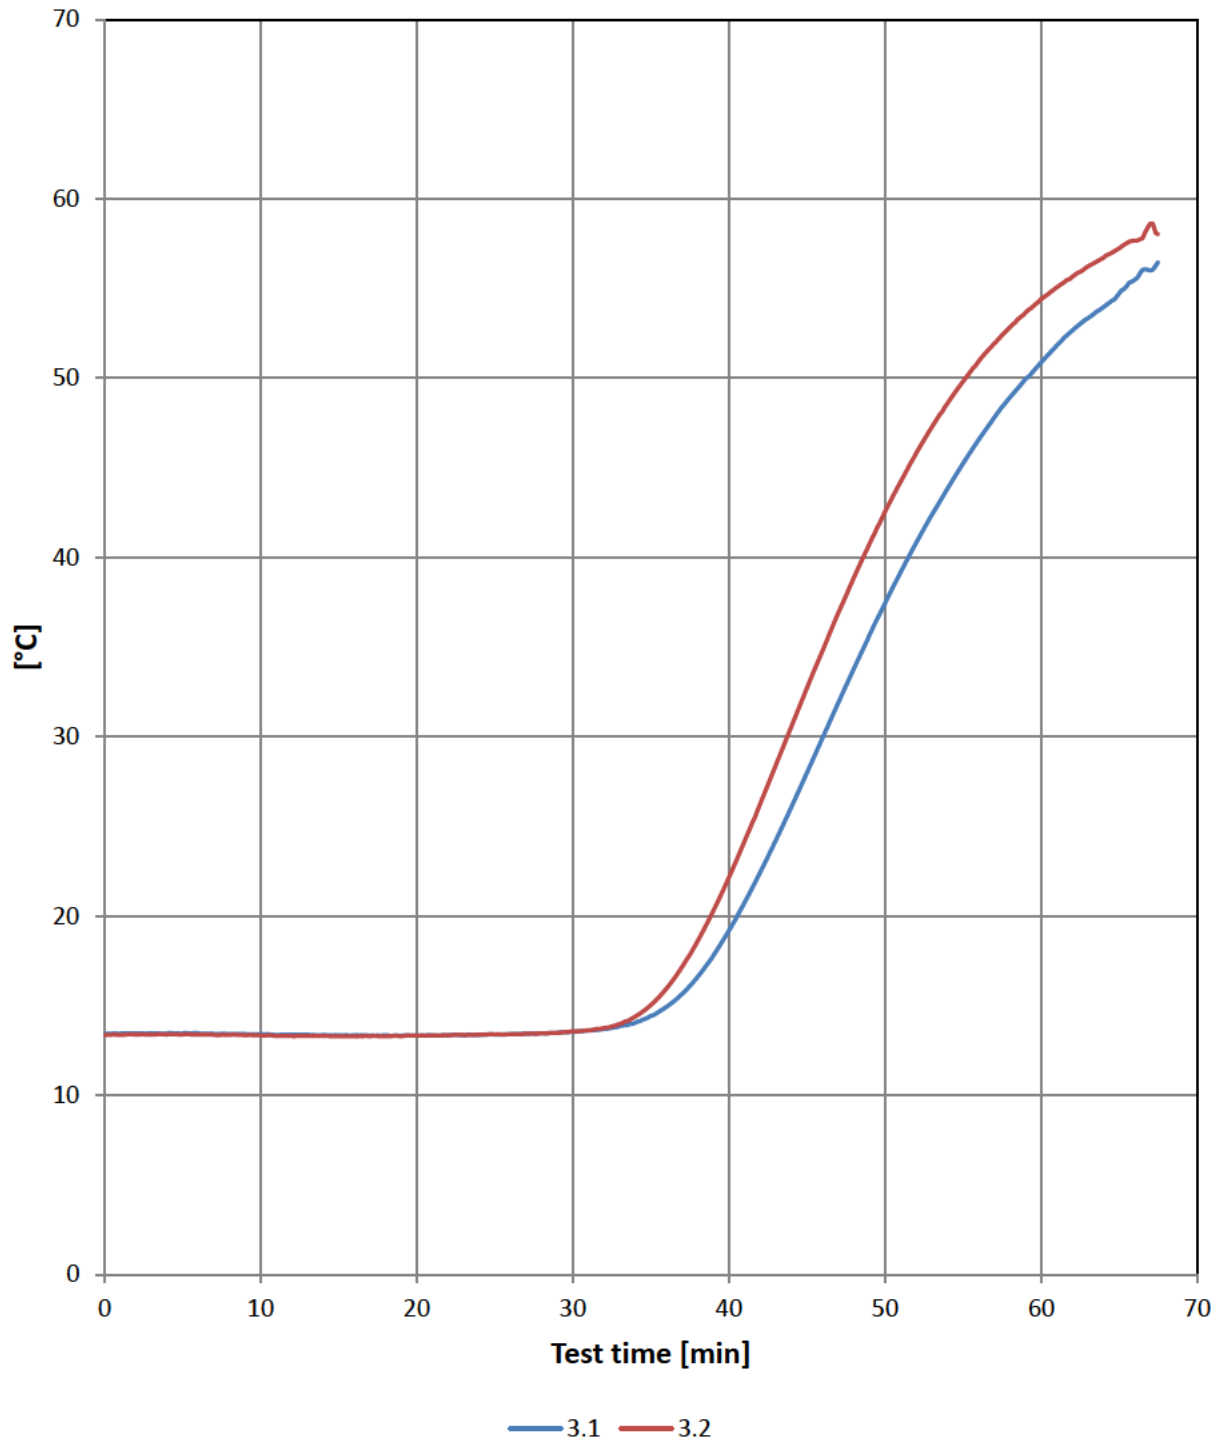
Internal temperature - between clay boards

Placed on center board 250 mm from the edge at each side at mid height

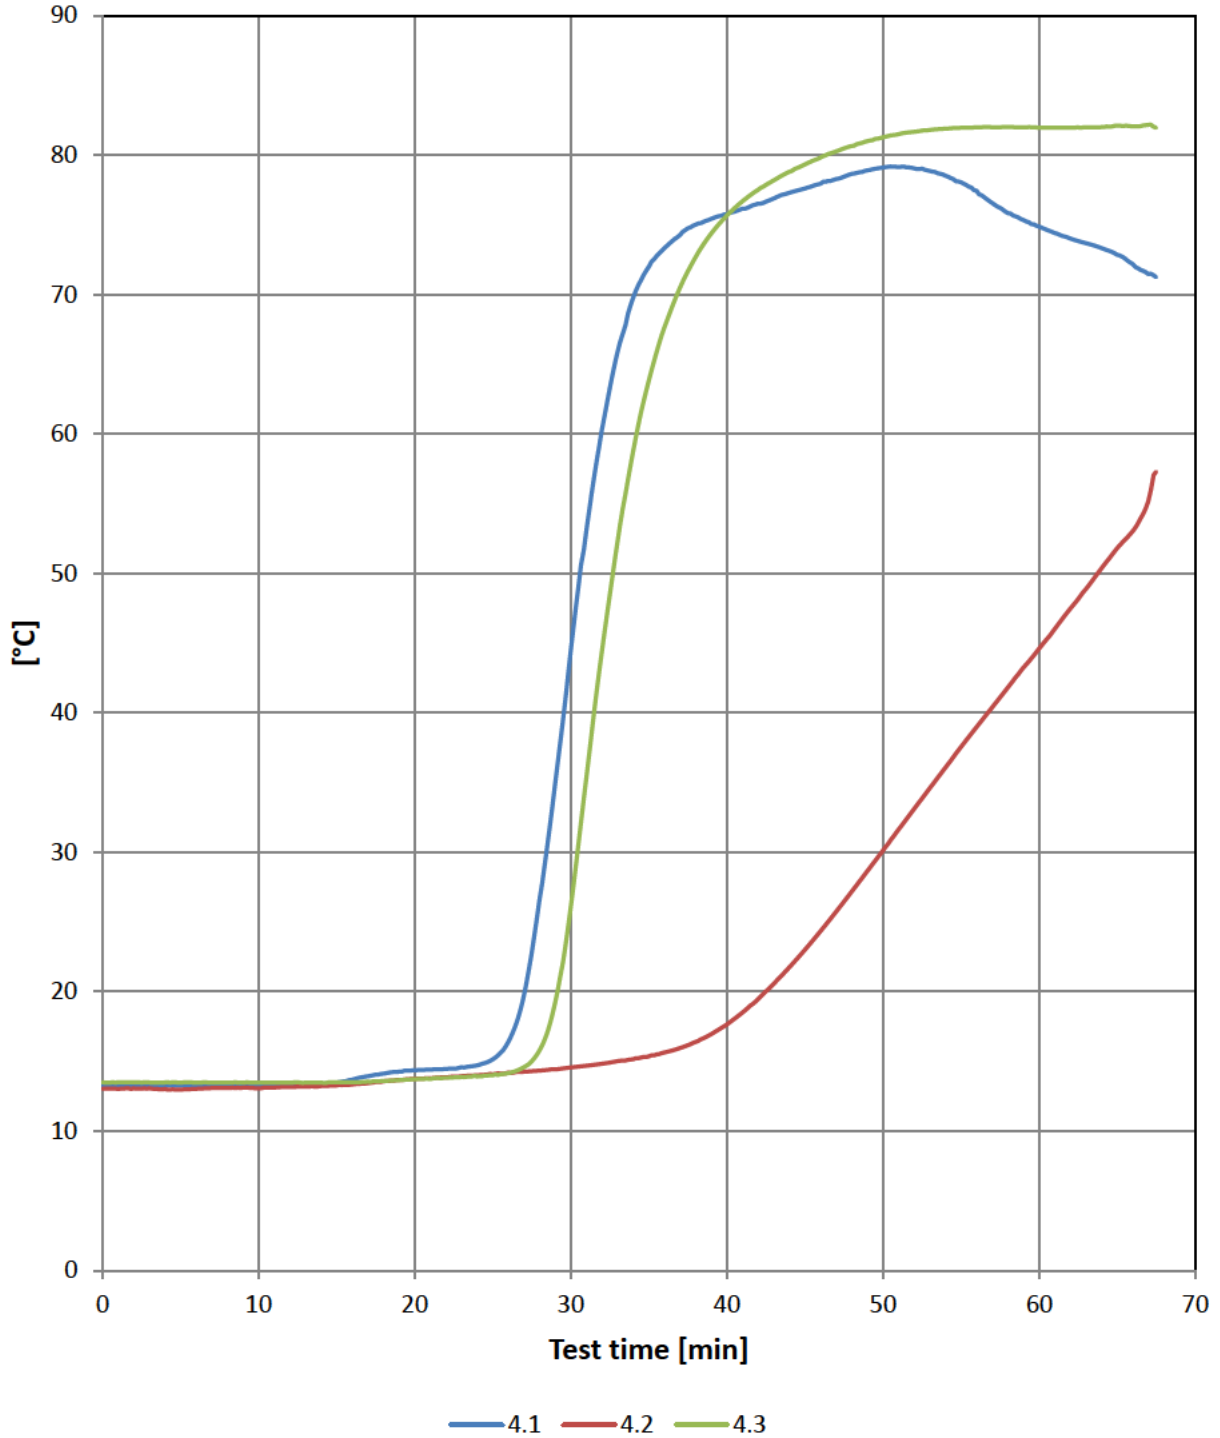
Additional thermocouples - Internal temperature - between studs and clay boards

mid height, 4.1 and 4.2 is placed on stud 2 and 3 from the left, and 4.3 is placed on insulation between stud 3 and 4.

Enclosures 9.0 and 9.1	<p>Additional thermocouples - Internal temperature - between studs and clay boards mid height, 4.1 and 4.2 is placed on stud 2 and 3 from the left, and 4.3 is placed on insulation between stud 3 and 4.</p>
Enclosures 10.0 and 10.1	<p>Internal temperature - on studs</p> <p>Placed on the back side of the unexposed wooden studs at stud 3 and 4 from the left.</p>
Enclosures 11.0 and 11.1	<p>Additional thermocouples - Internal temperature - between studs and clay board exposed side</p> <p>6.1 and 6.2 is placed 750 mm from top on insulation between 2 and 3, and 3 and 4 respectively. 6.3 and 6.4 is placed mid height on studs 2 and 3 from the left. 6.5 is placed 750 mm from bottom on insulation between stud 3 and 4.</p>

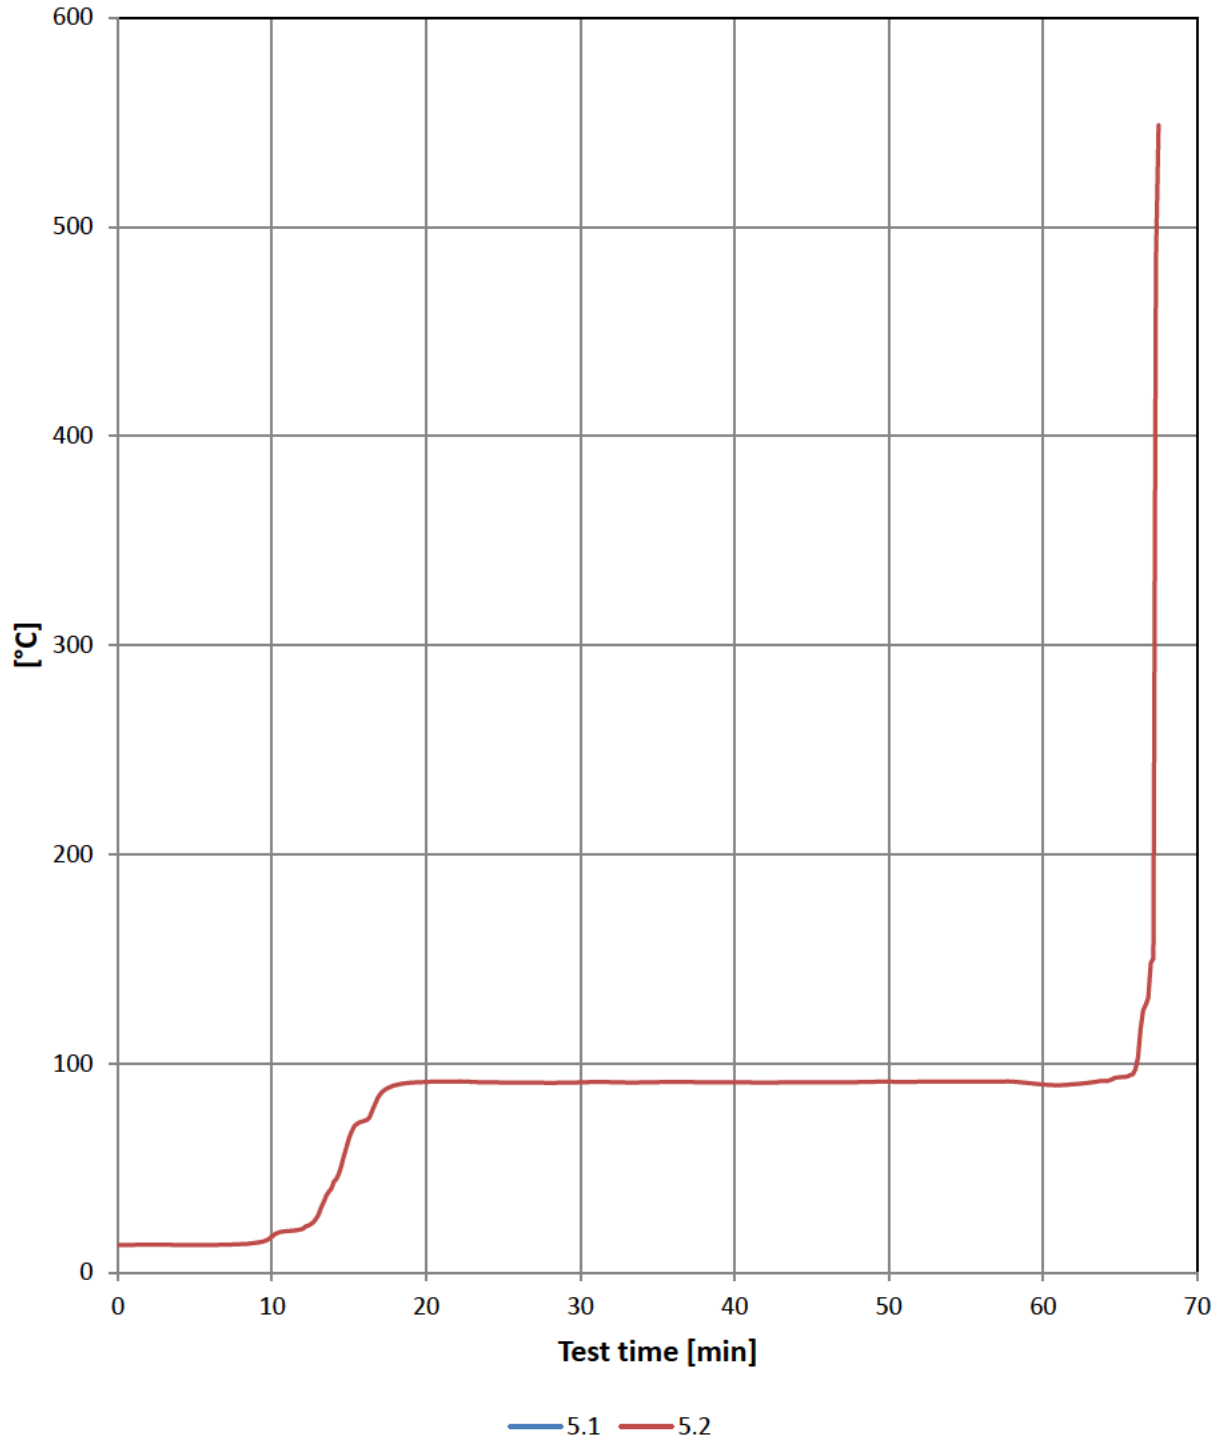
Internal temperature - on studs

Placed on the back side of the unexposed wooden studs at stud 3 and 4 from the left.

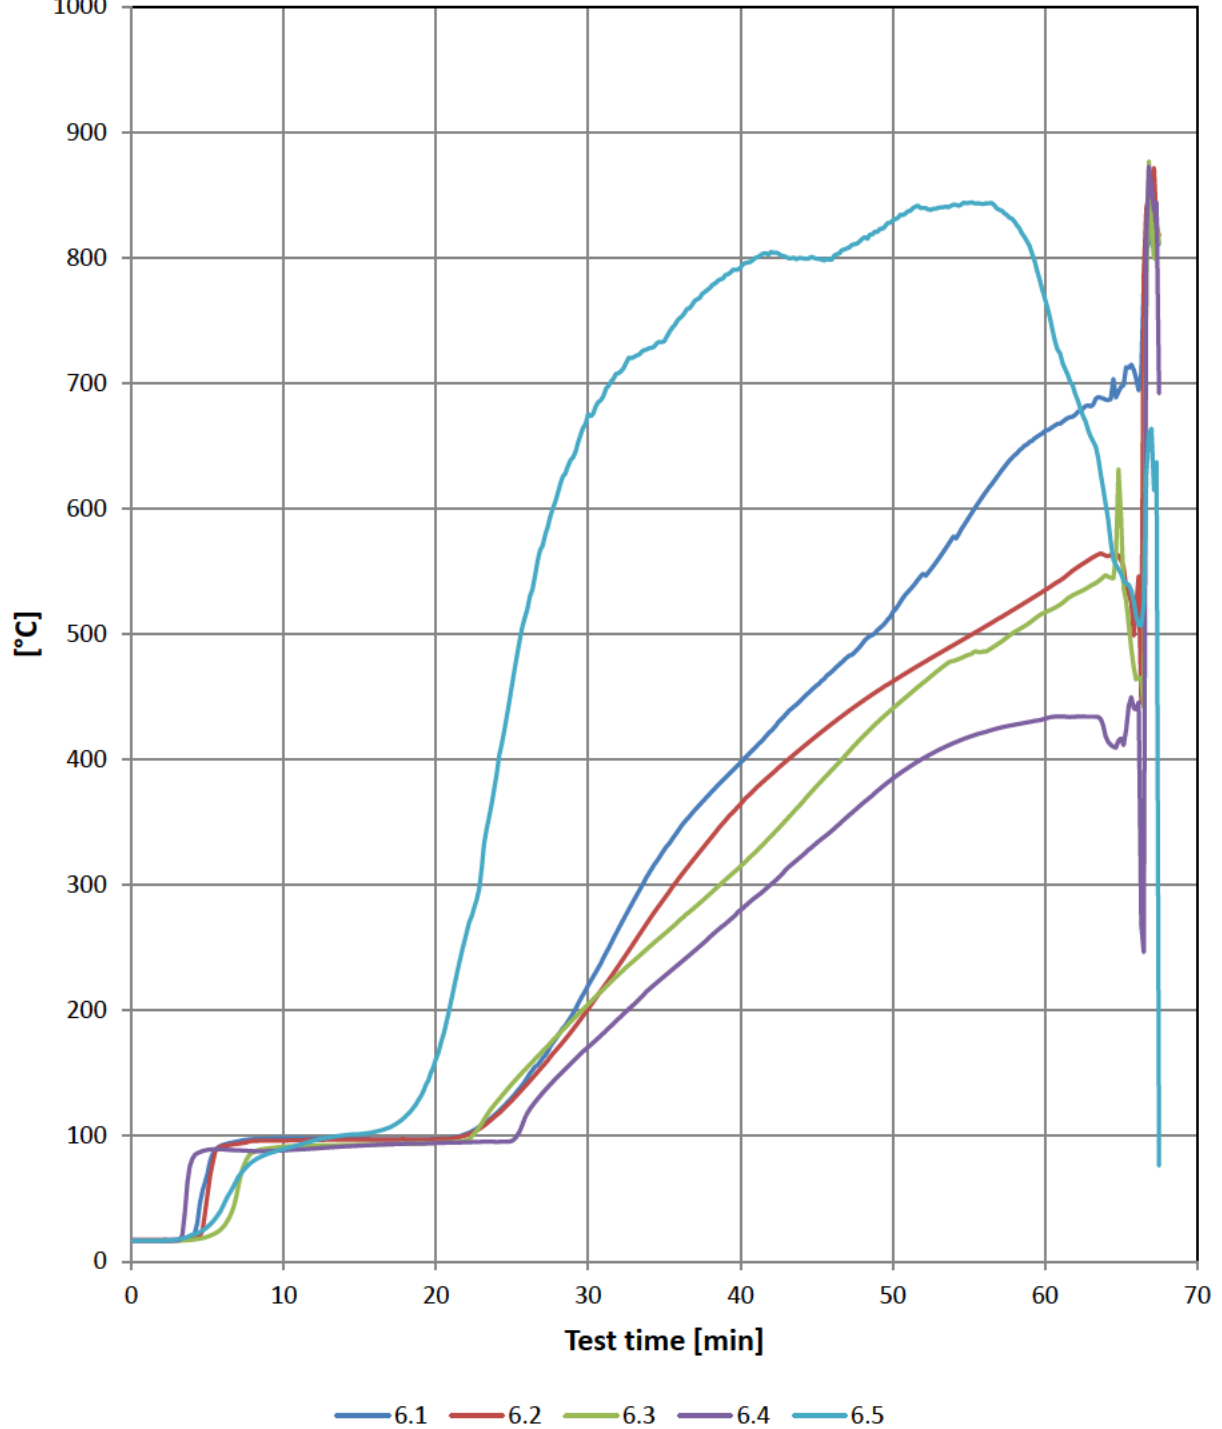
Additional thermocouples - Internal temperature - between studs and clay board exposed side

6.1 and 6.2 is placed 750 mm from top on insulation between 2 and 3, and 3 and 4 respectively. 6.3 and 6.4 is placed mid height on studs 2 and 3 from the left. 6.5 is placed 750 mm from bottom on 1000

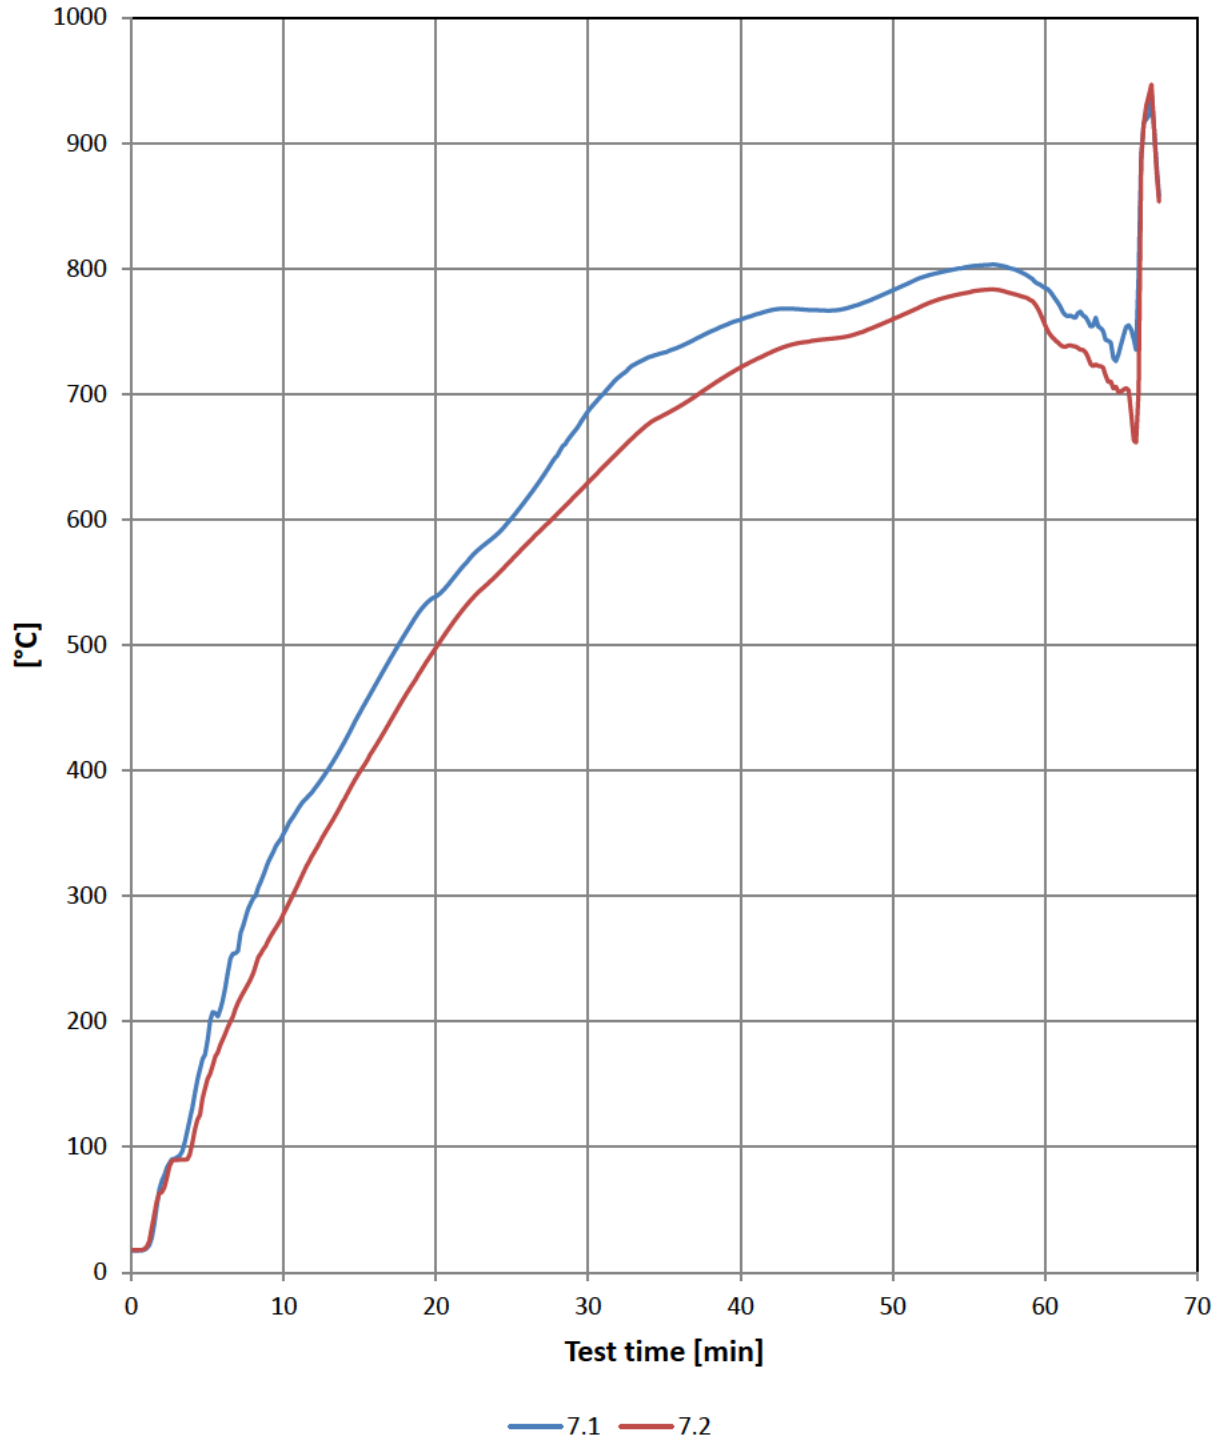
Additional thermocouples - Internal temperature - between clay boards exposed side

Placed on the left side full board 250 mm from the edge at each side at mid height of construction

Enclosures 12.0 and 12.1	Additional thermocouples - Internal temperature - between clay boards exposed side Placed on the left side full board 250 mm from the edge at each side at mid height of construction
Enclosures 13.0 and 13.1	Maximum temperature in the construction layers
Enclosures 14.0 and 14.1	Deformation horizontal Positive values indicate movement away from the furnace
Enclosures 15.0 and 15.1	Horizontal deformation Negative values indicate movement towards the furnace The deformation data malfunctions the first 10 min of the test.
Enclosures 16.0 and 16.1	Vertical deformation Negative values indicate downwards movement The deformation data malfunctions the first 10 min of the test.
Enclosures 17.0 and 17.1	Vertical deformation rate The deformation data malfunctions the first 10 min of the test.
Enclosures 18.0 and 18.1	Horizontal deformation during loading Negative values indicate movement towards the furnace
