TEST REPORT

LOADBEARING WALL

Name of sponsor:	Wood:UpHigh		
Product name:	Loadbearing wall		
File no.:	PGA12247A	Revision no.:	0
Test date:	08/03/2023	Date:	14-07-2023
Pages:	11	Encl.:	55
Ref:	MRD / JBK

EN 1365-1:2012 Fire resistance tests for loadbearing elements Part 1: Walls

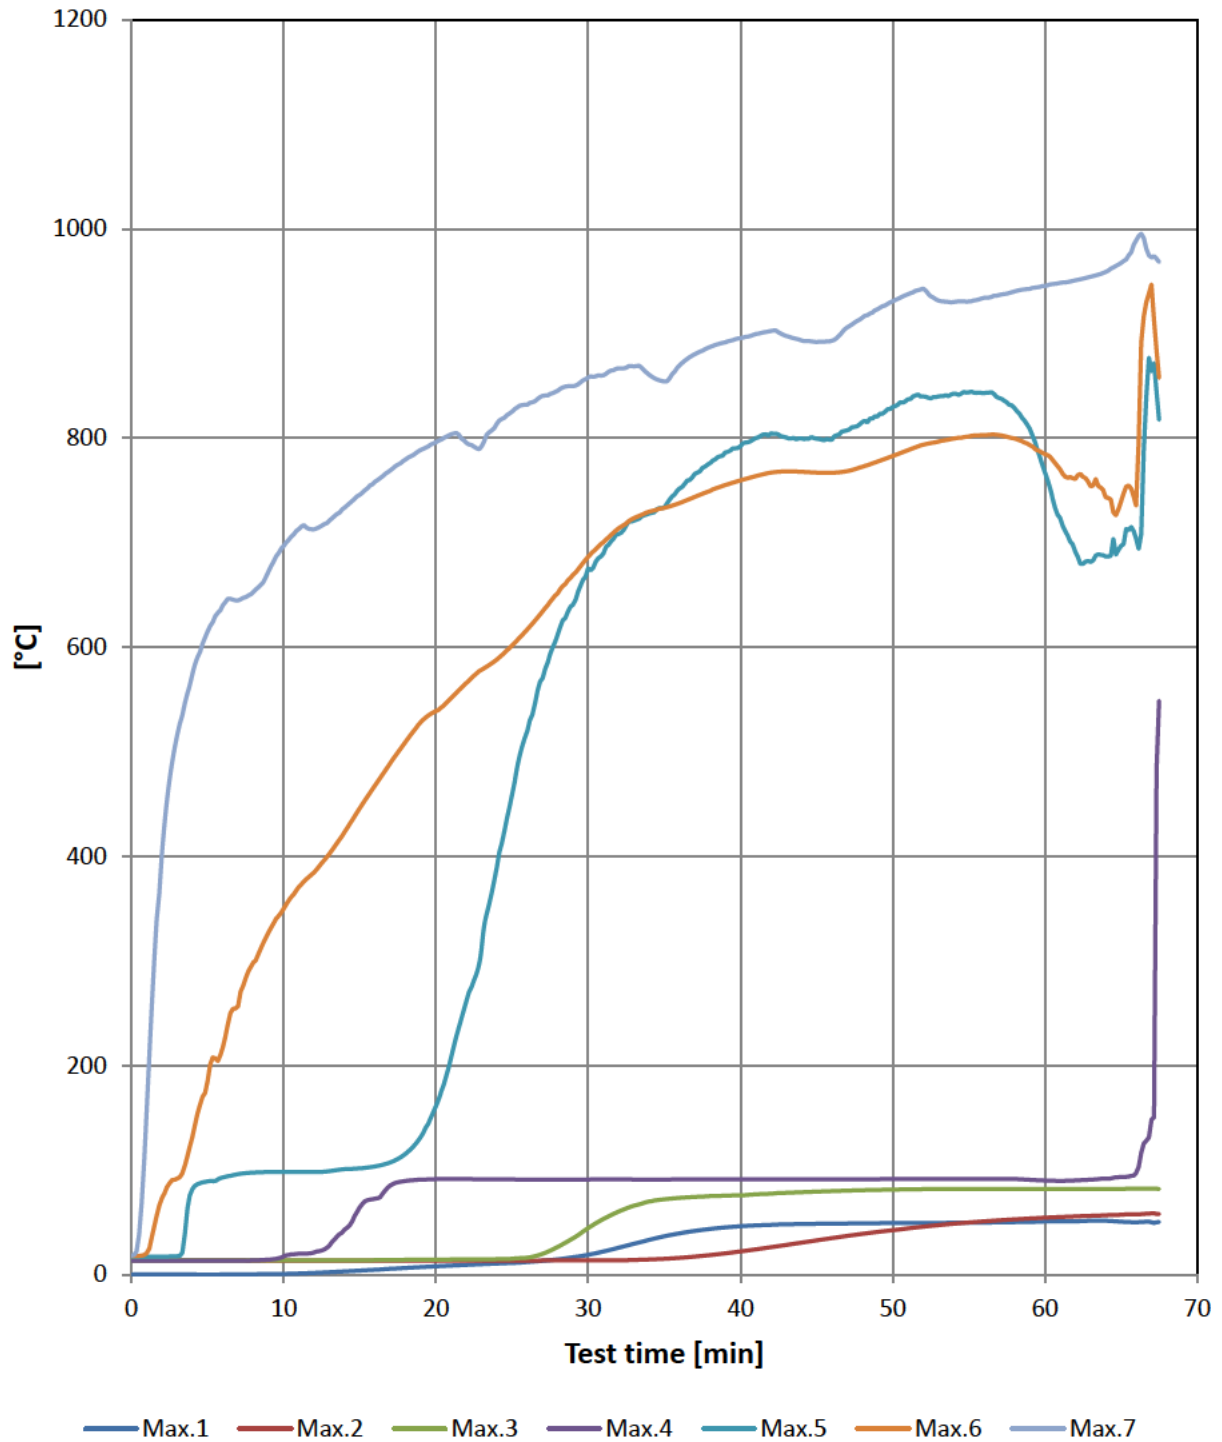
Maximum temperature in the construction layers

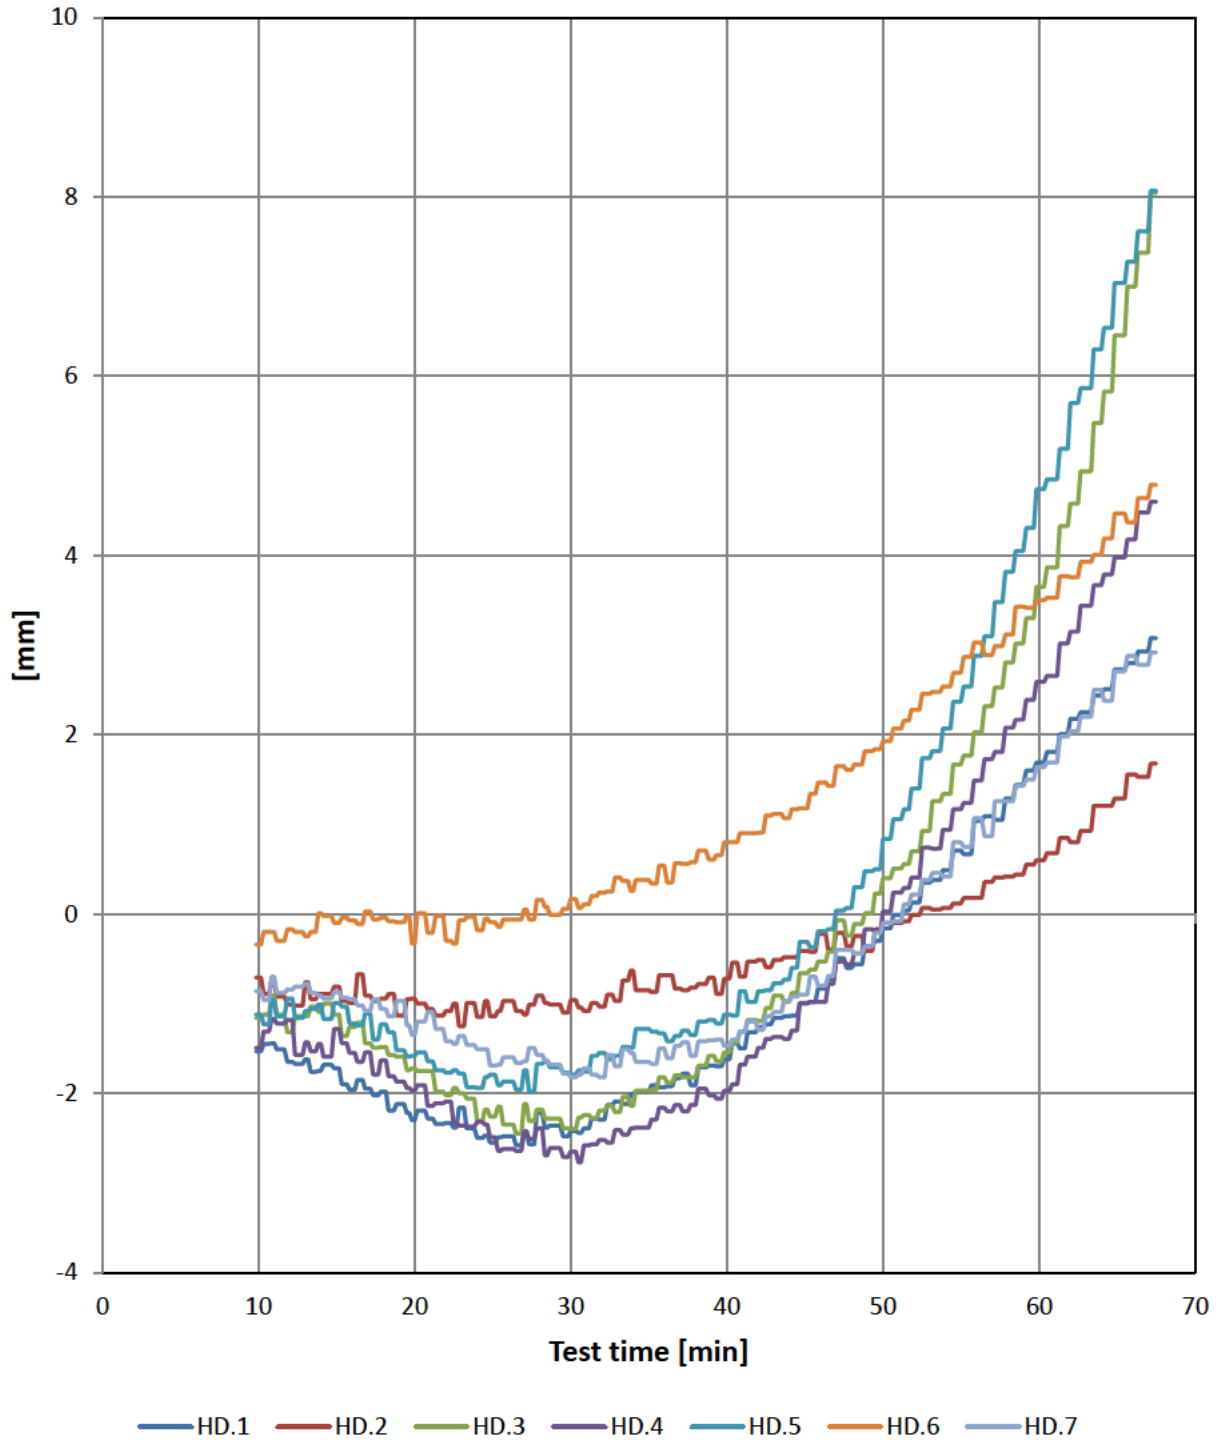
Horizontal deformation

Negative values indicate movement towards the furnace

The deformation data malfunctions the first 10 min of the test.

The deformation data malfunctioned during the first 10 minutes of the test. The measurements have been zeroed with the last measurement after the loading phase was completed and the start of the fire test.

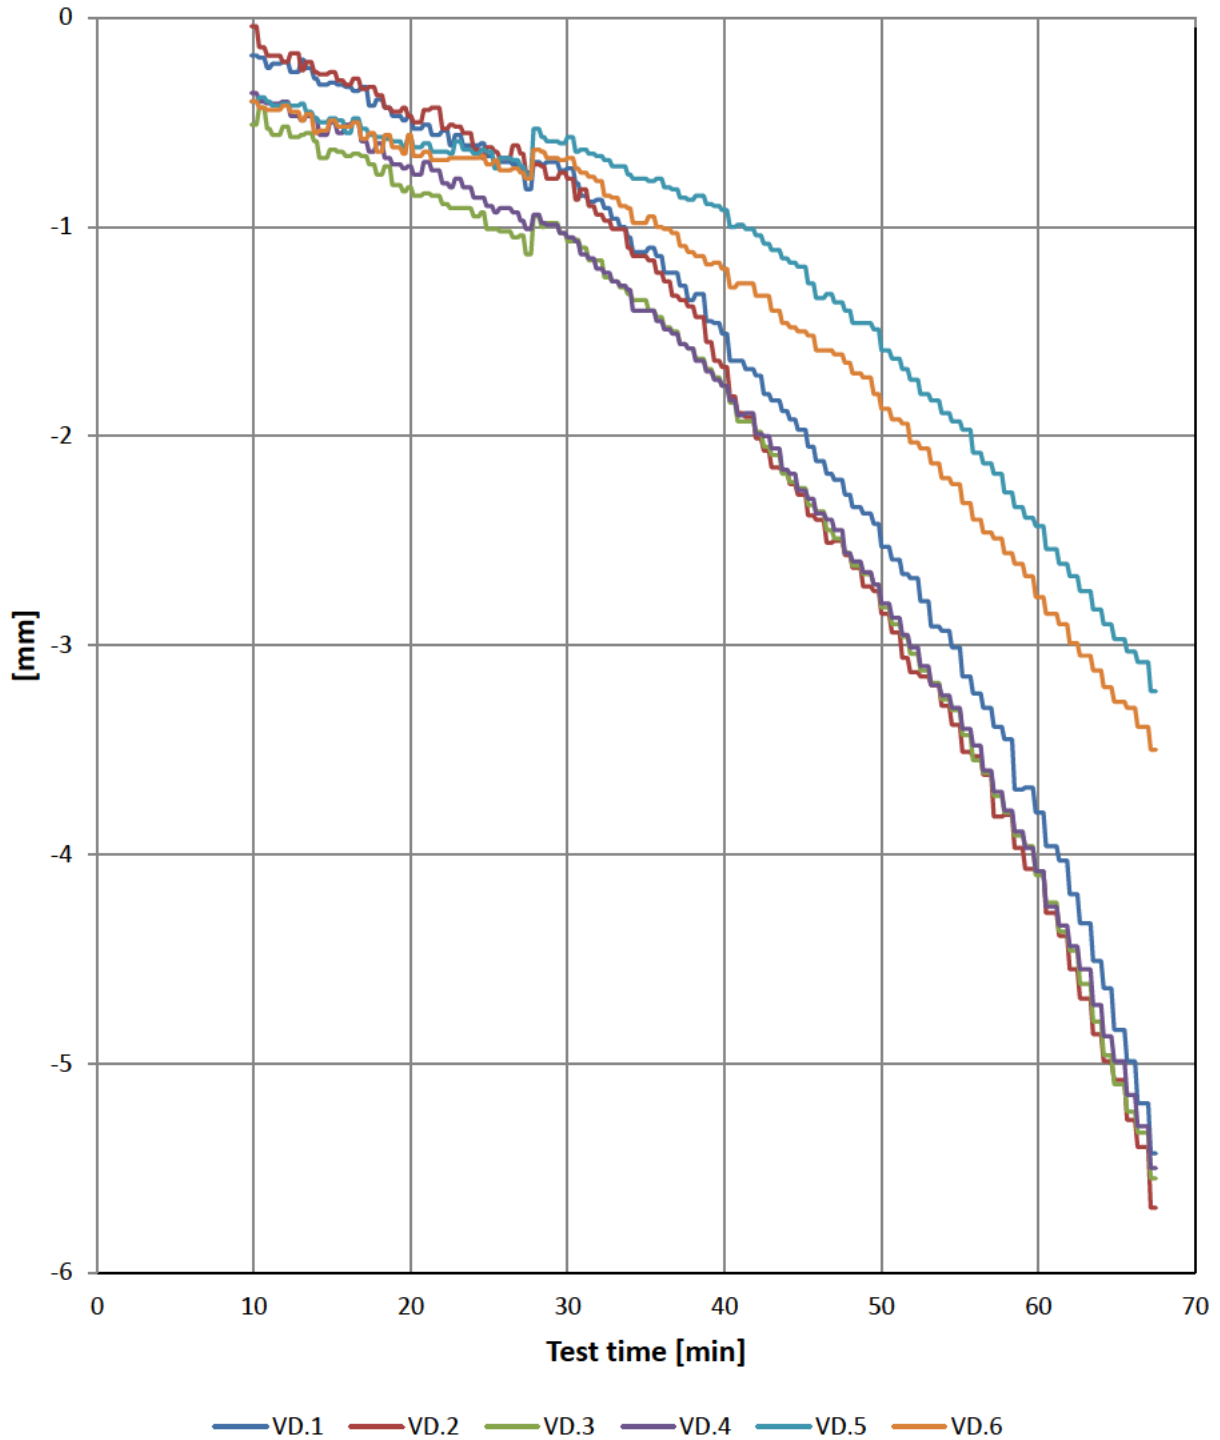
Vertical deformation

Negative values indicate downwards movement

The deformation data malfunctions the first 10 min of the test.

- The load on the test specimen was maintained for 66 minutes.
- The measured vertical deflection did not exceed the criteria of $C = h/100 = 29$ mm during the test.
- The measured rate of vertical deflection did not exceed the criteria of $dC/dt = 3h/1000 = 9$ mm/min during the test.

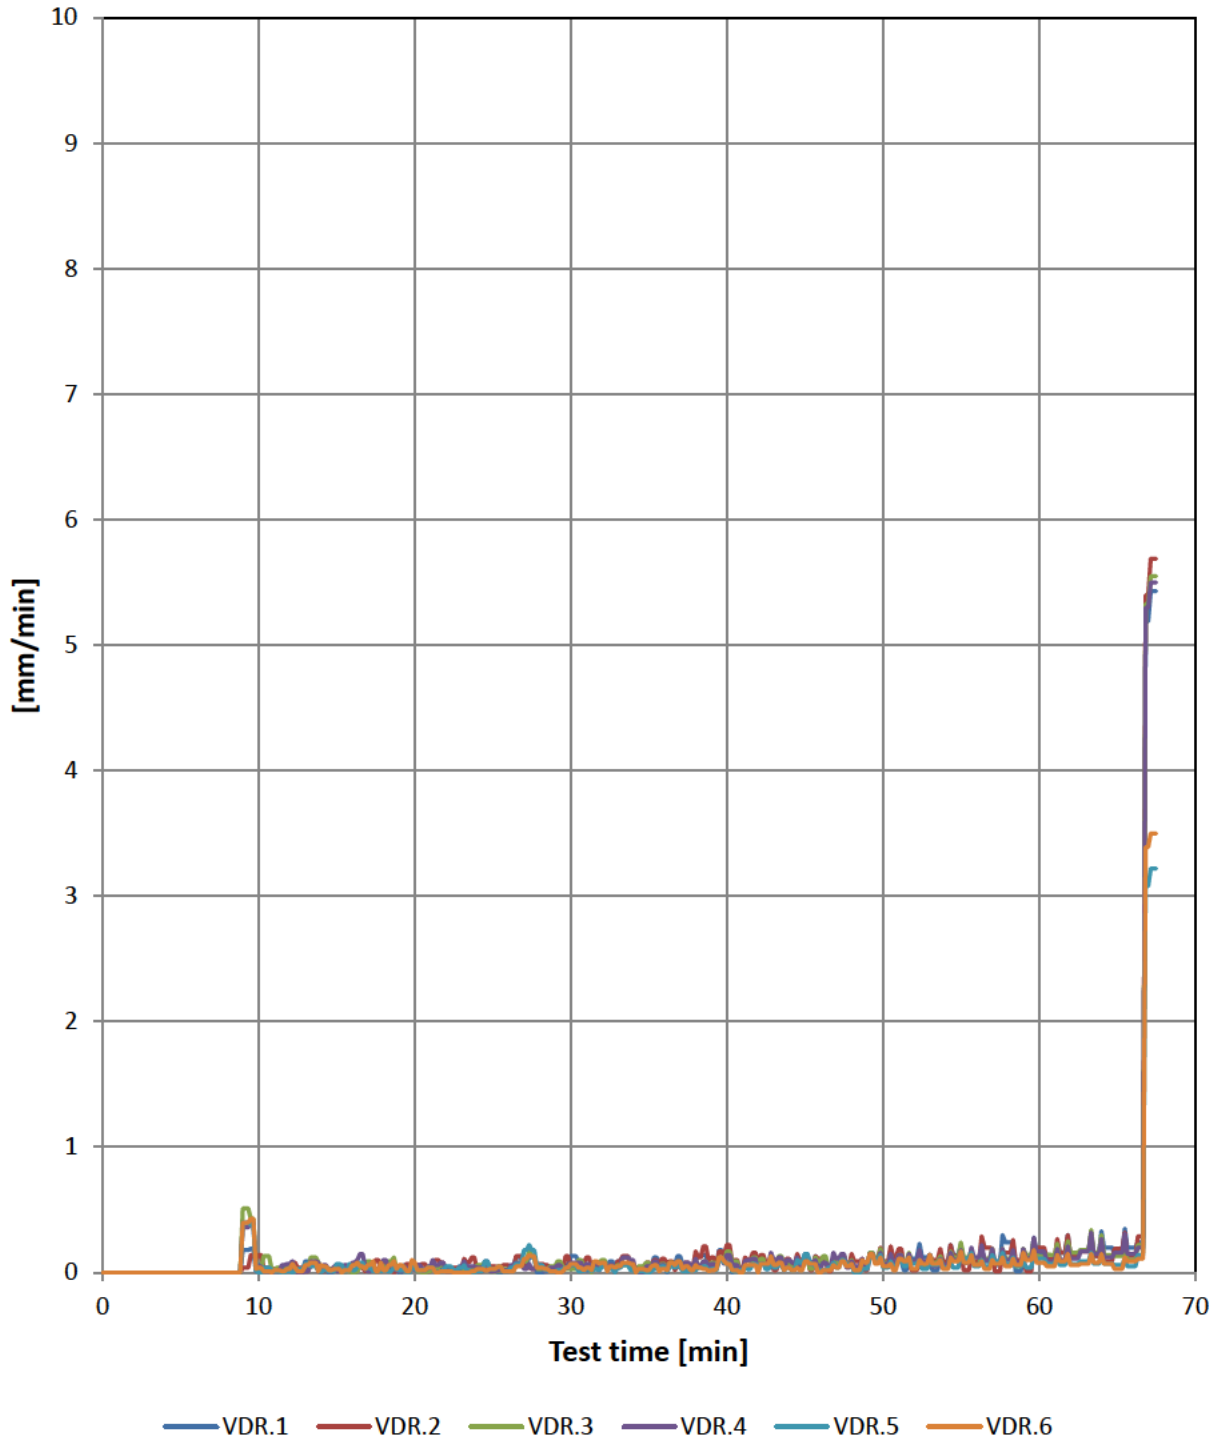
Vertical deformation rate

The deformation data malfunctions the first 10 min of the test.

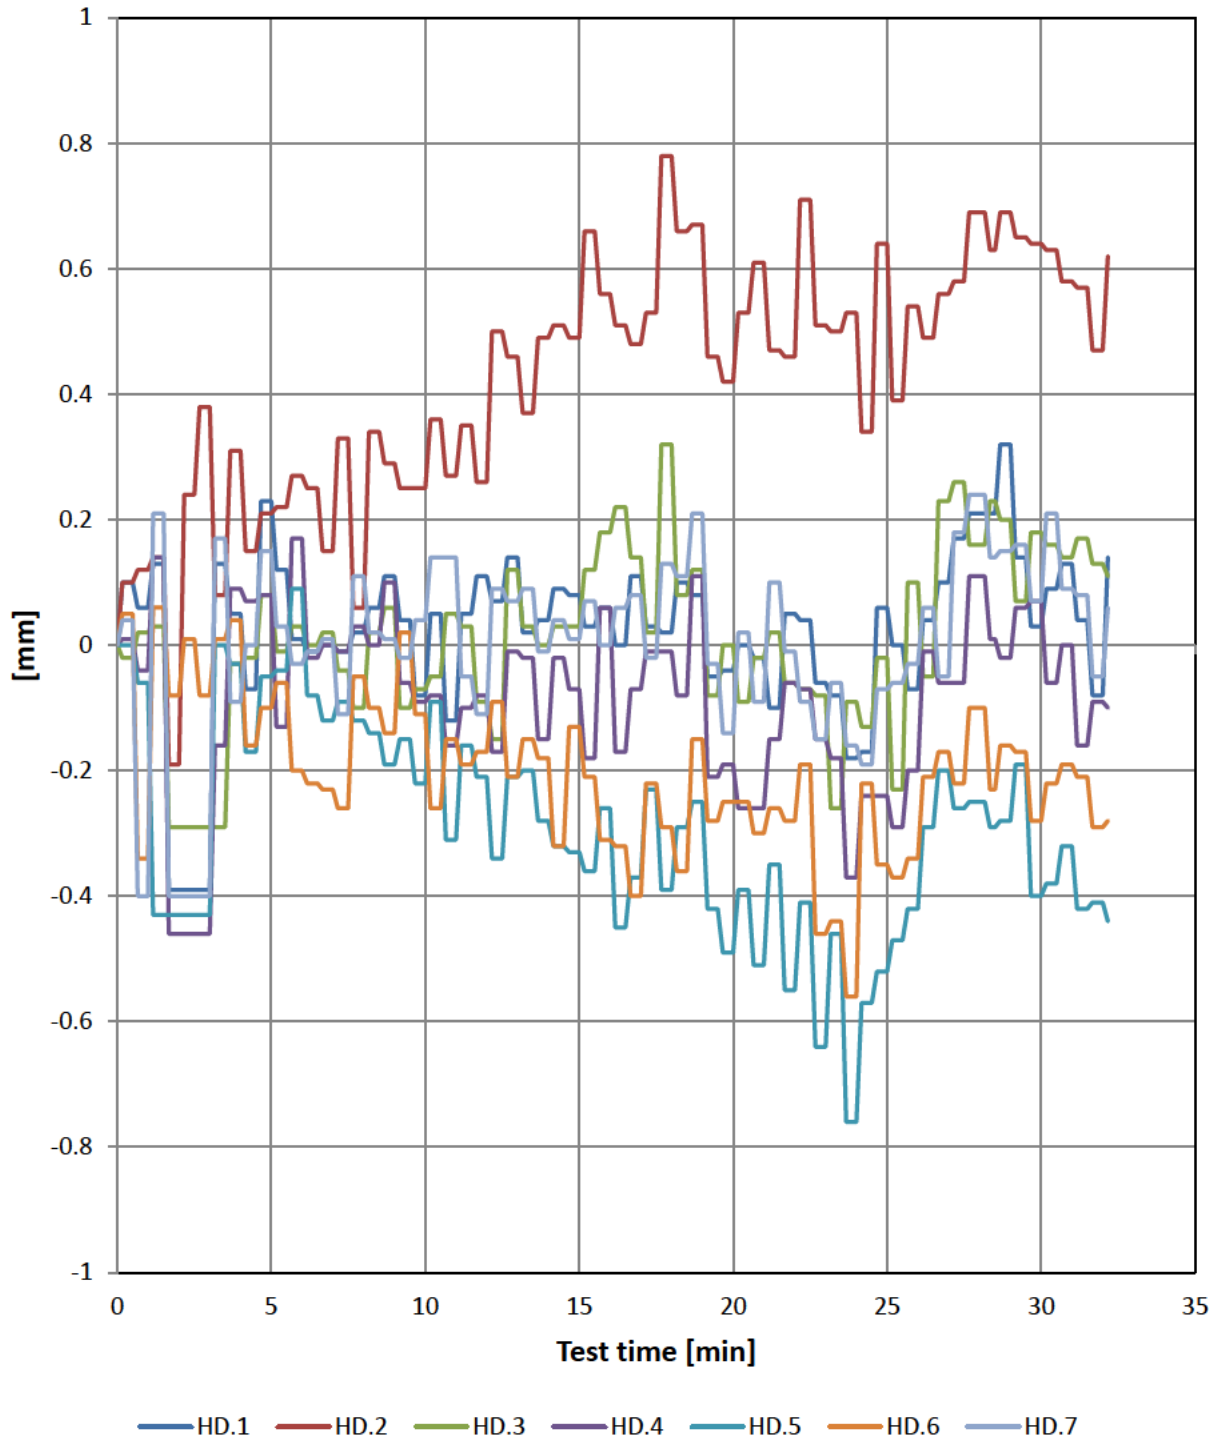
Horizontal deformation during loading

Negative values indicate movement towards the furnace

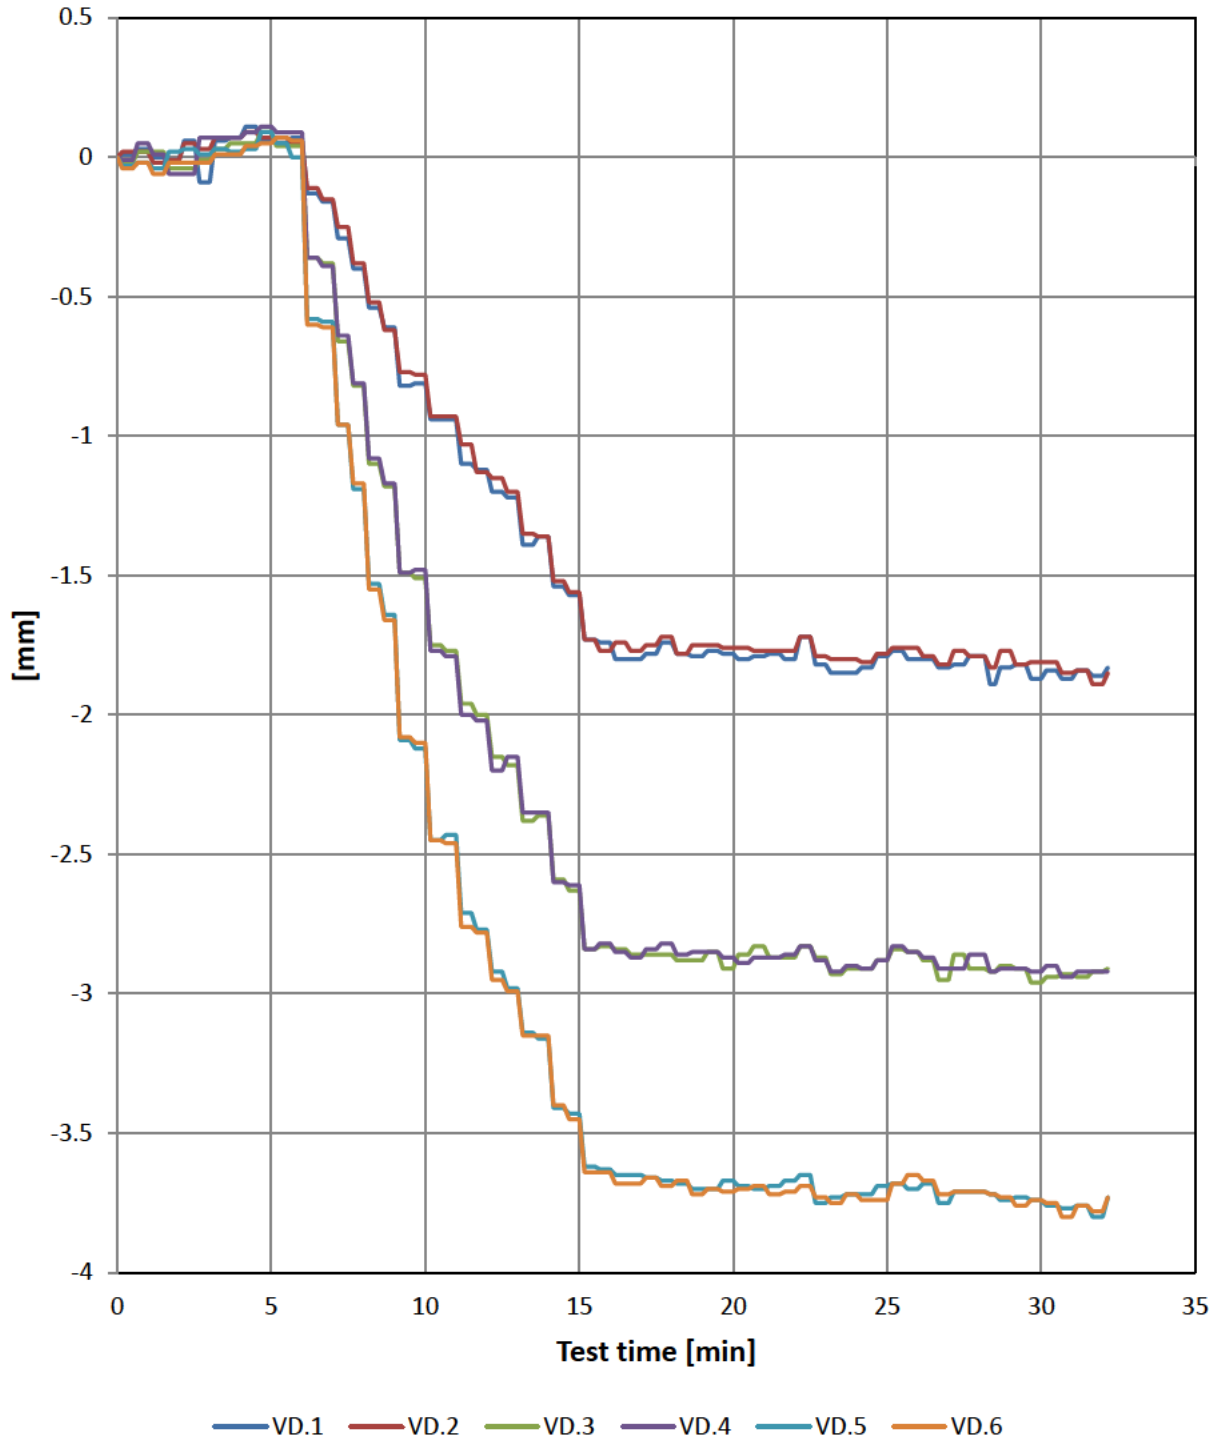
Vertical deformation during loading

Negative values indicate downwards movement

Enclosures 19.0 and 19.1	Vertical deformation during loading Negative values indicate downwards movement
Enclosures 20.0 and 20.1	Load per cylinder during loading Load per cylinder

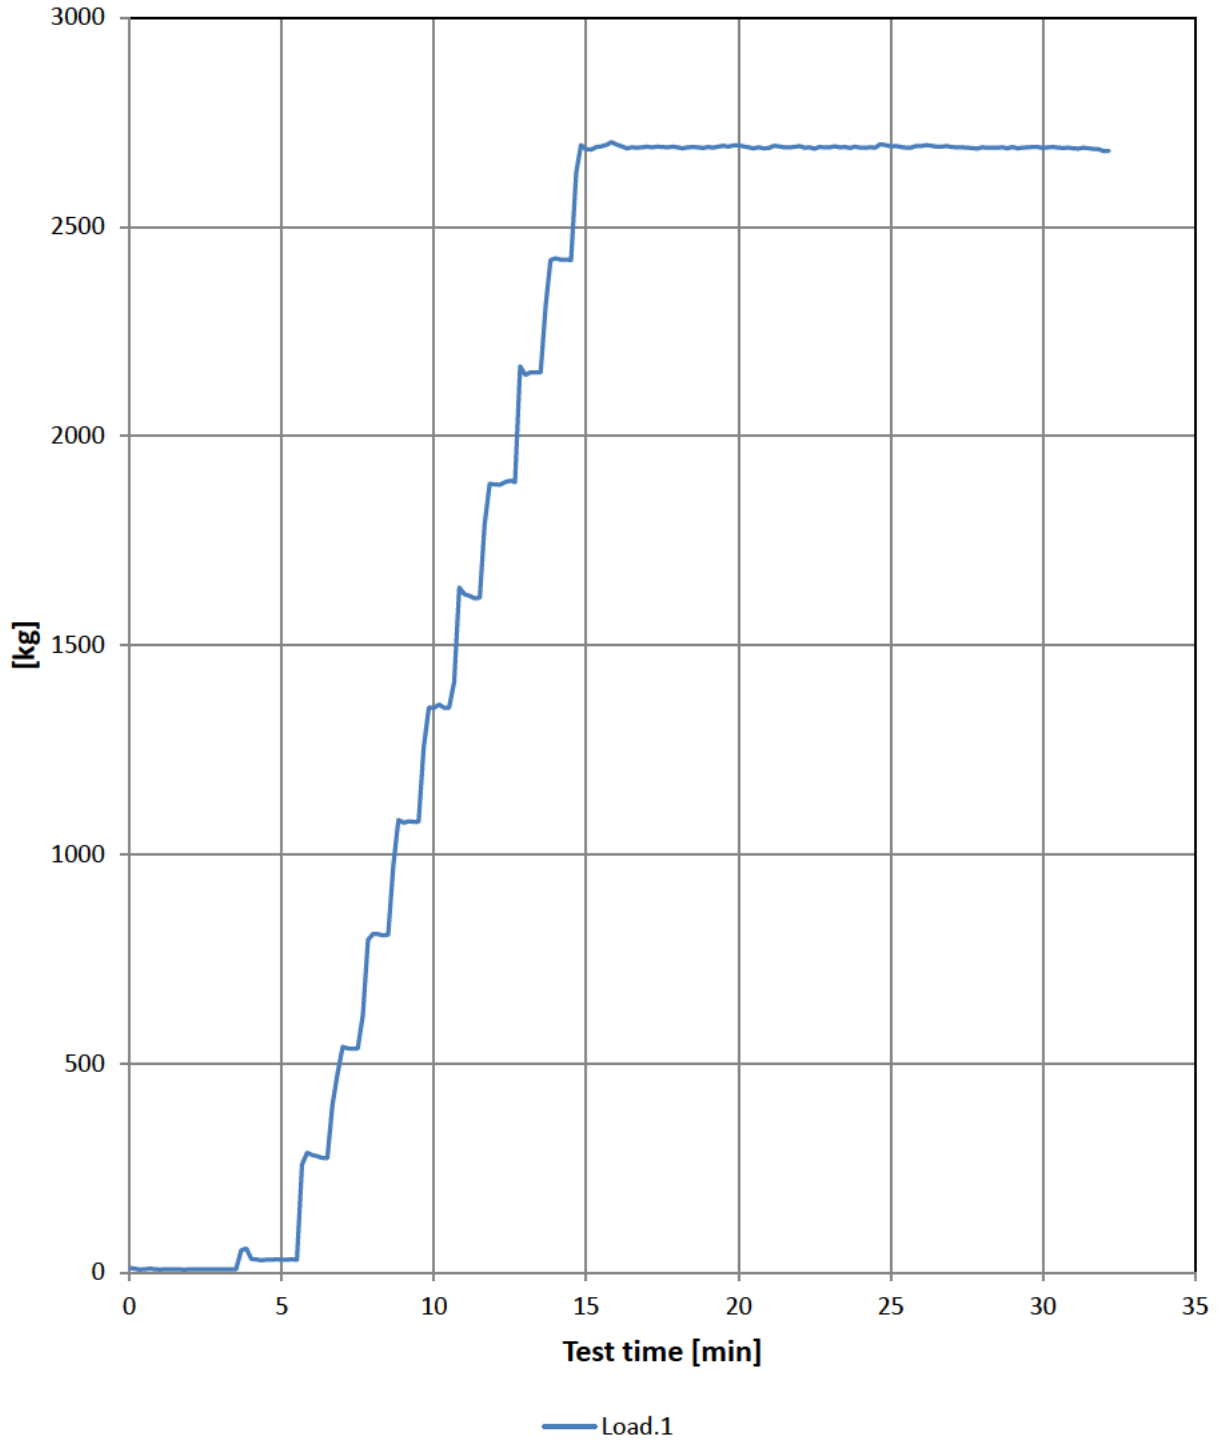
Load per cylinder during loading

Load per cylinder

The load was applied in 10 steps prior to the fire test. The fire test was commenced approx. 30 minutes after reaching the final load on the test specimen.

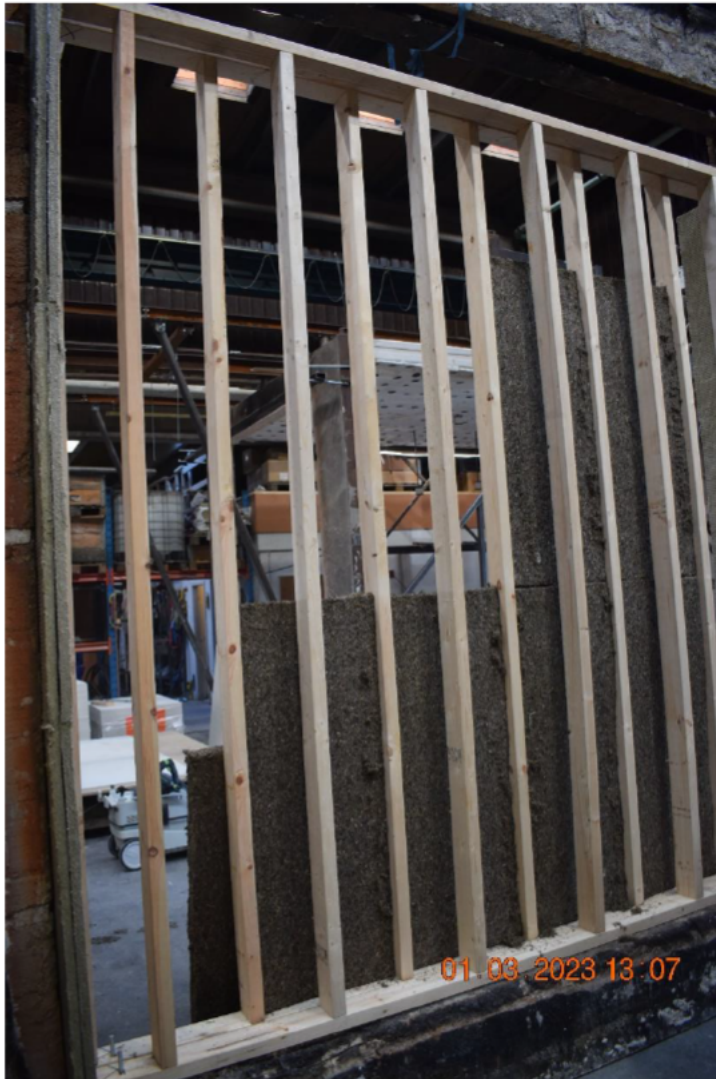
Photo No. 1 Timber frame of specimen, with seaweed insulation.

A total of 13 studs were used in the wall construction, all 2910 mm tall. The studs are 45 x 95 mm dry graded C24 construction spruce wood with a nominal density of 450 kg/m³. The studs were spaced c/c 500 mm.

Two timber frames were constructed with 250 mm staggered studs. The airgap between the two timber frames were 40 mm.

See drawing no. 1.3 and 1.4 and photo no. 1.

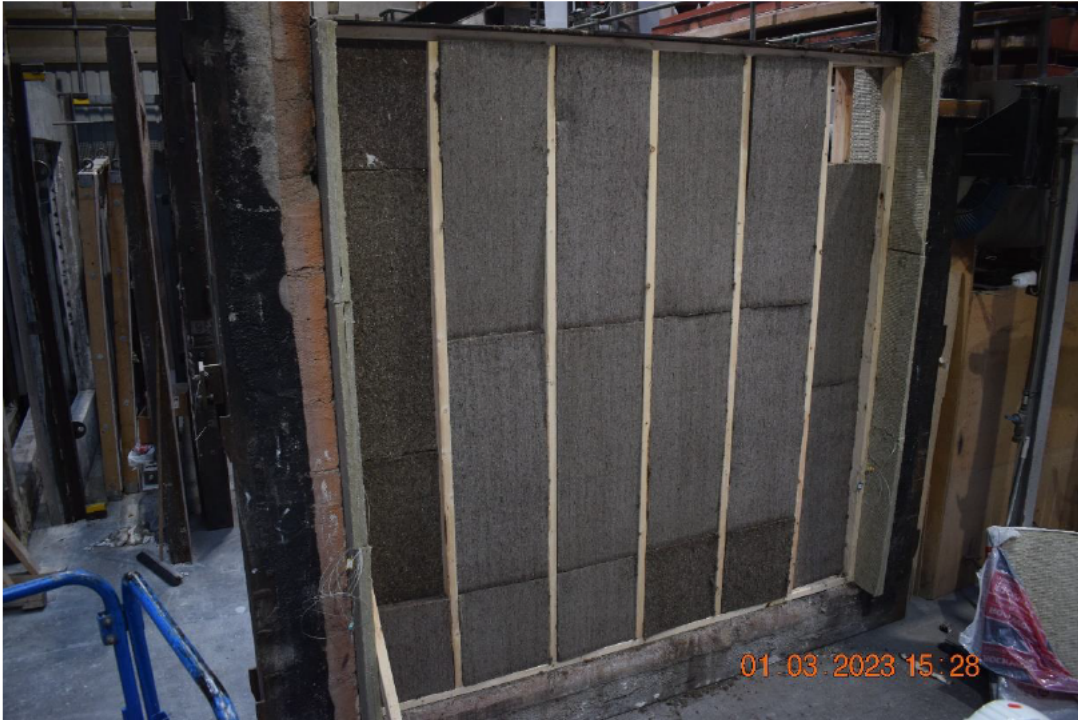
Photo No. 2 Timber frame of specimen, with seaweed insulation.

Insulation: The insulation material used was a seaweed wool designated [REDACTED] the insulation was used in two layers in each frame, which gives a total of 4 layers throughout the construction.

The insulation had a nominal thickness of 65 mm and a nominal density of 80 kg/m³.

See photo no. 2.

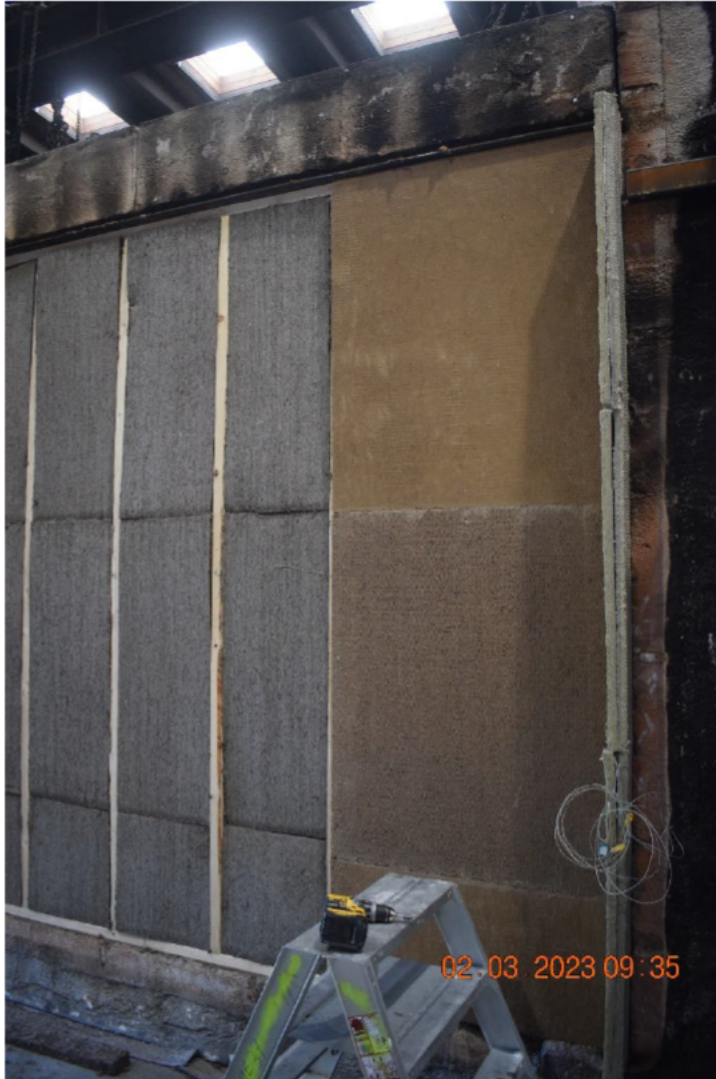
Photo No. 3 Timber frame of specimen, with seaweed insulation and first layer of clay board

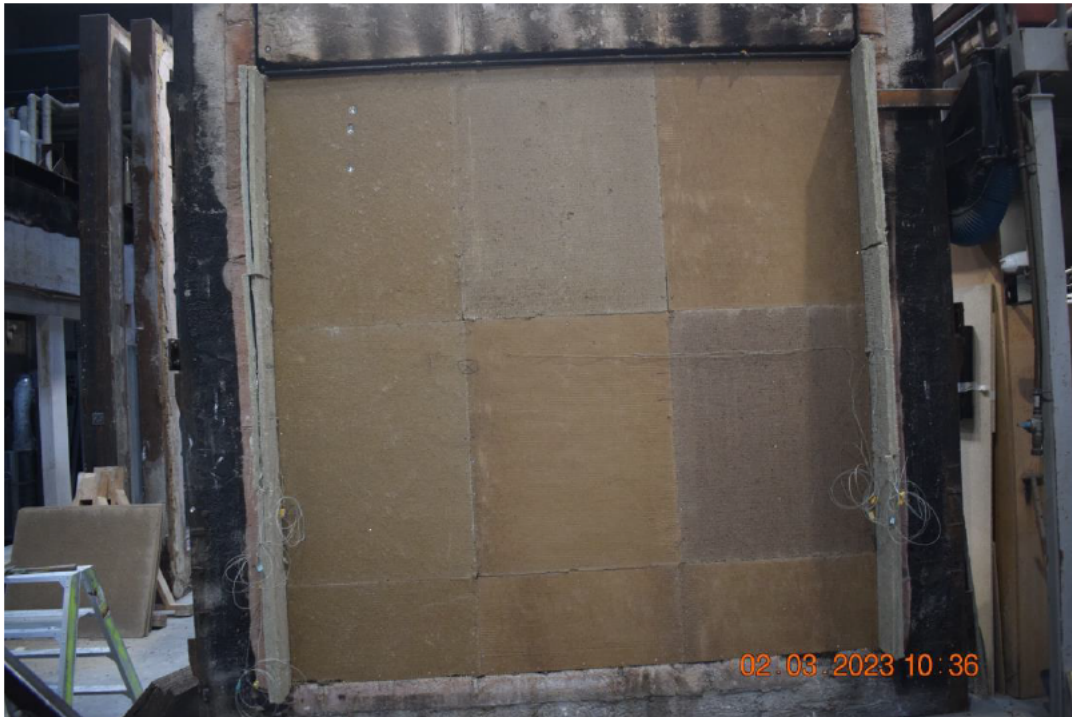
Photo No. 4a Unexposed side of test specimen, inner layer of clay boards.

Inner clay boards designated [REDACTED] with the nominal dimensions of 22 x 1250 x 1000 mm with a nominal density of 750 kg/m³ was mounted on the exposed side to the loadbearing studs with 3,9 x 35 mm gypsum screws. Seven screws were used in three rows against the loadbearing studs, with 15 mm to the board edge.

See photo no. 4a and 5a.

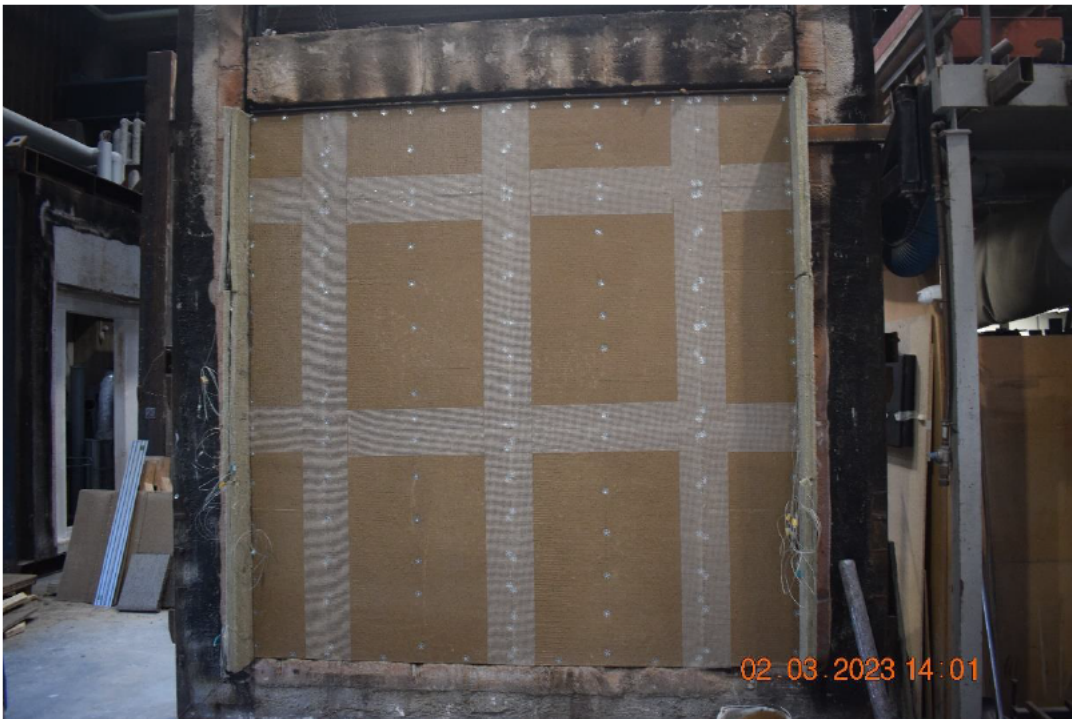
Photo No. 4b Unexposed side of test specimen, outer layer of clay boards, before clay plaster was added.

Outer layer clay boards designated [REDACTED] with the nominal dimensions of 10 x 1250 x 1000 mm with a nominal density of 750 kg/m³. This layer was fixed with 3.9 x 45 mm screws with a Ø35 mm washer. The washer had a thickness of 0.7 mm. A total of 21 screws were used for a full board with 7 in each row.

See photo no. 4b and 5b.

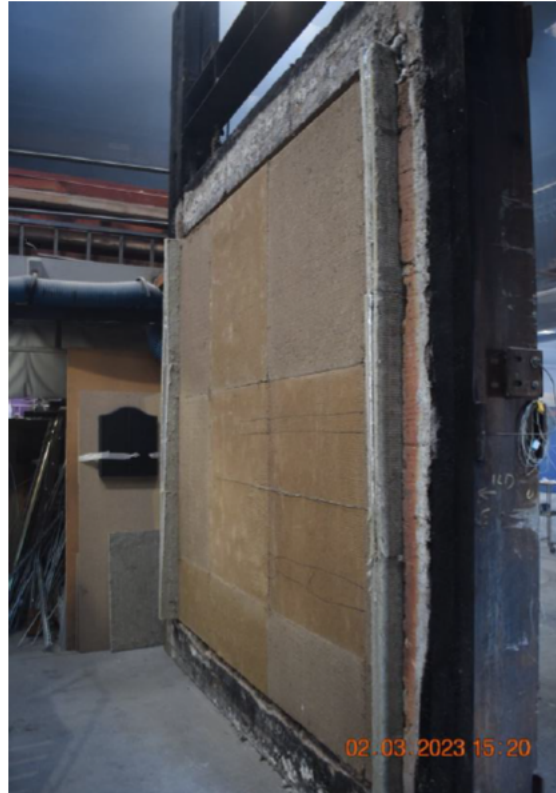
Photo No. 5a Test specimen seen from exposed side – inner layer of clay boards.

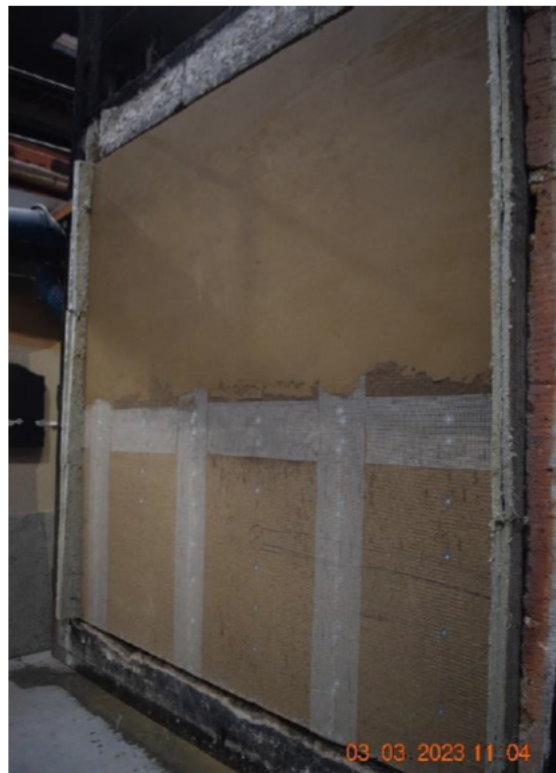
Photo No. 5b Test specimen with clay plaster being added

Plaster: The clay plaster designated [REDACTED] was used on both the exposed and unexposed side of the test specimen. The plaster was mixed according to the producers mixing instructions. The plaster was applied with approximately 3 mm layer.

See photo no. 5b.

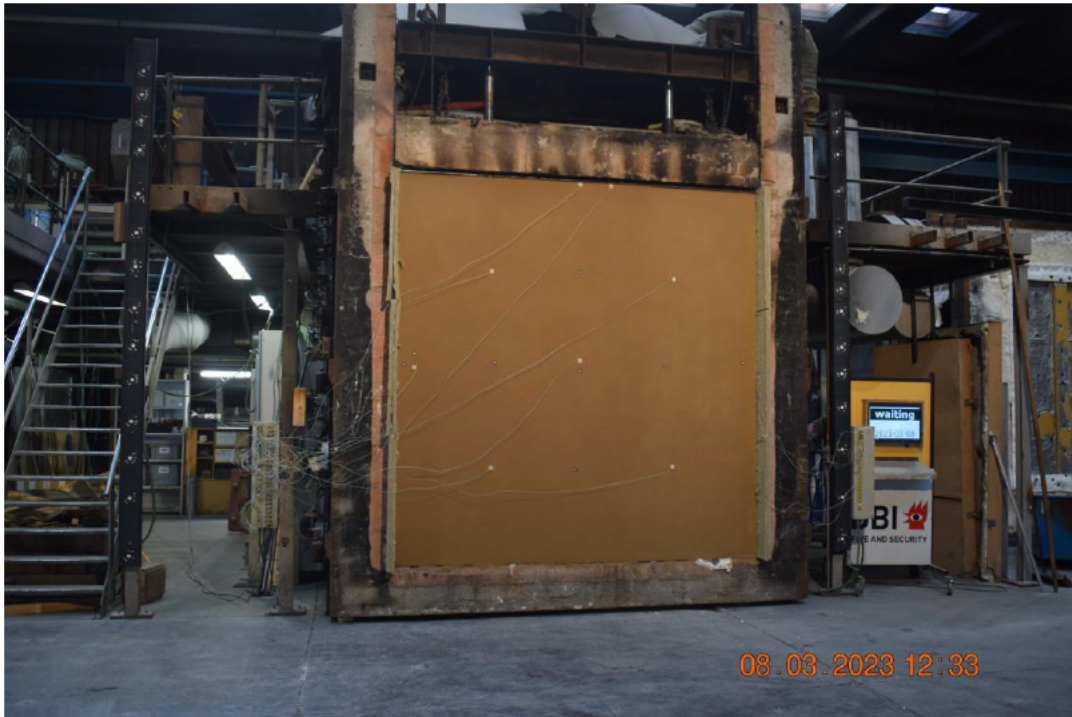
Photo No. 8 Test specimen seen from unexposed side after 30 minutes of testing

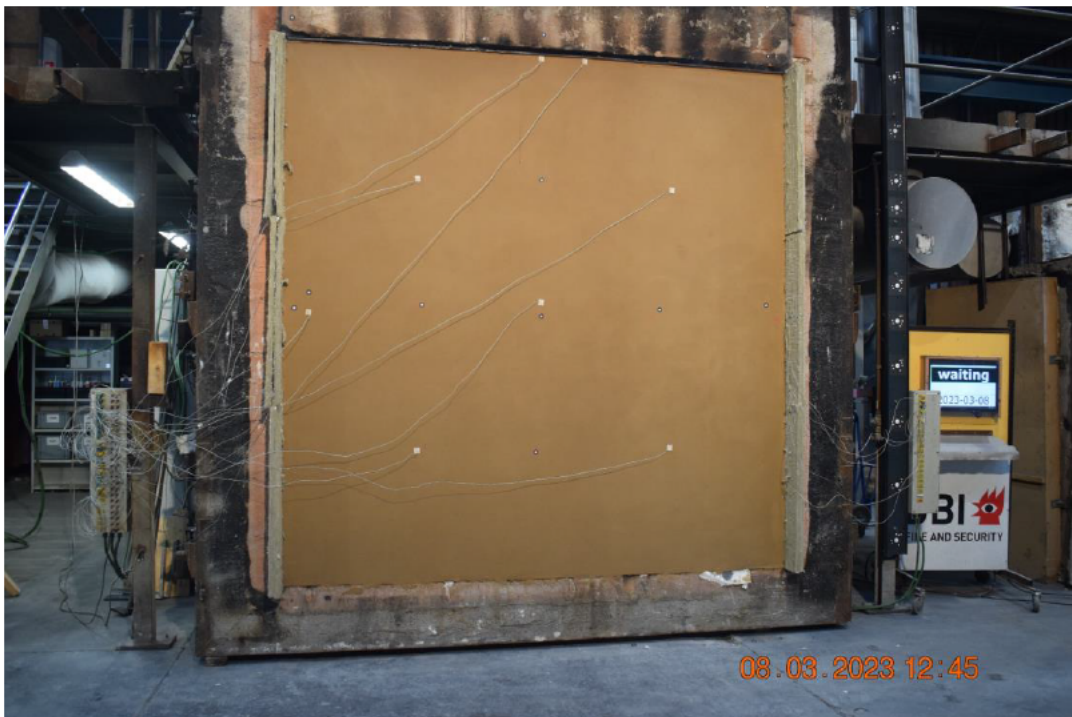
Photo No. 9 Test specimen seen from unexposed side after 42 minutes of testing

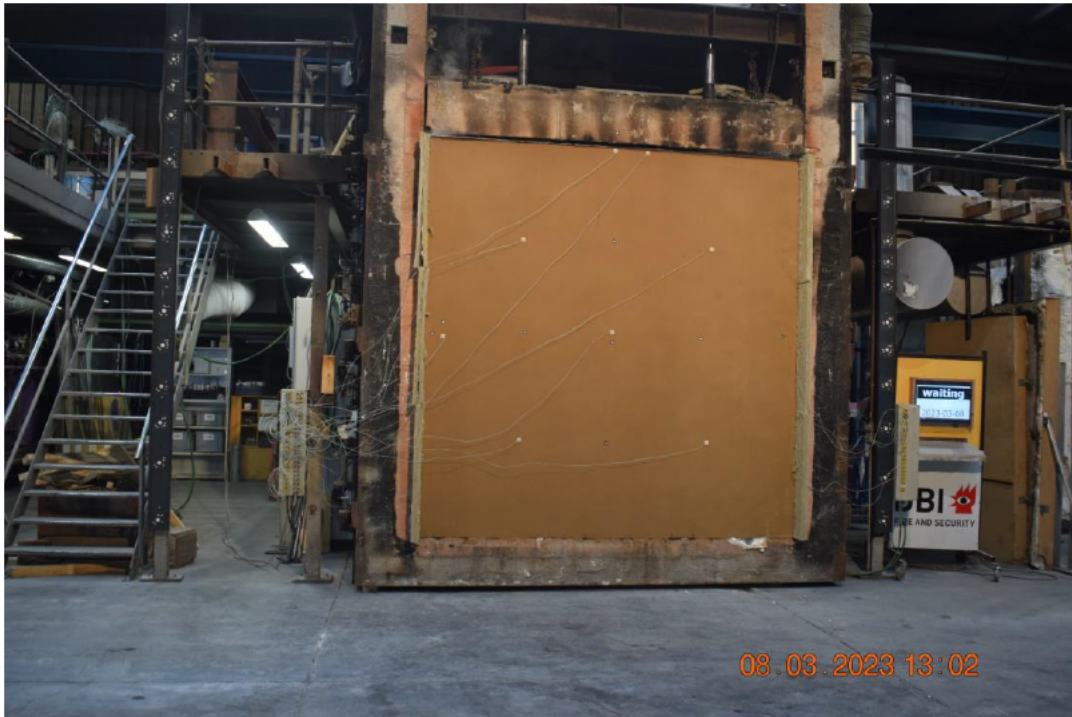
Photo No. 10 Test specimen seen from unexposed side after 60 minutes of testing

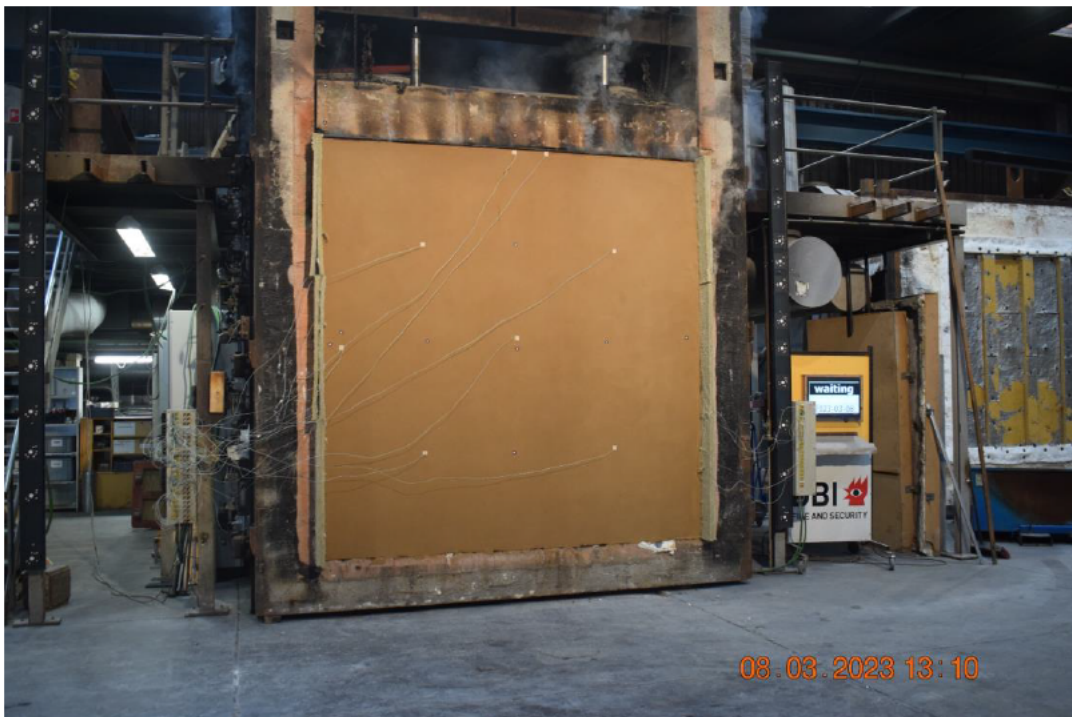
Photo No. 11 Test specimen seen from unexposed side after 67 minutes of testing

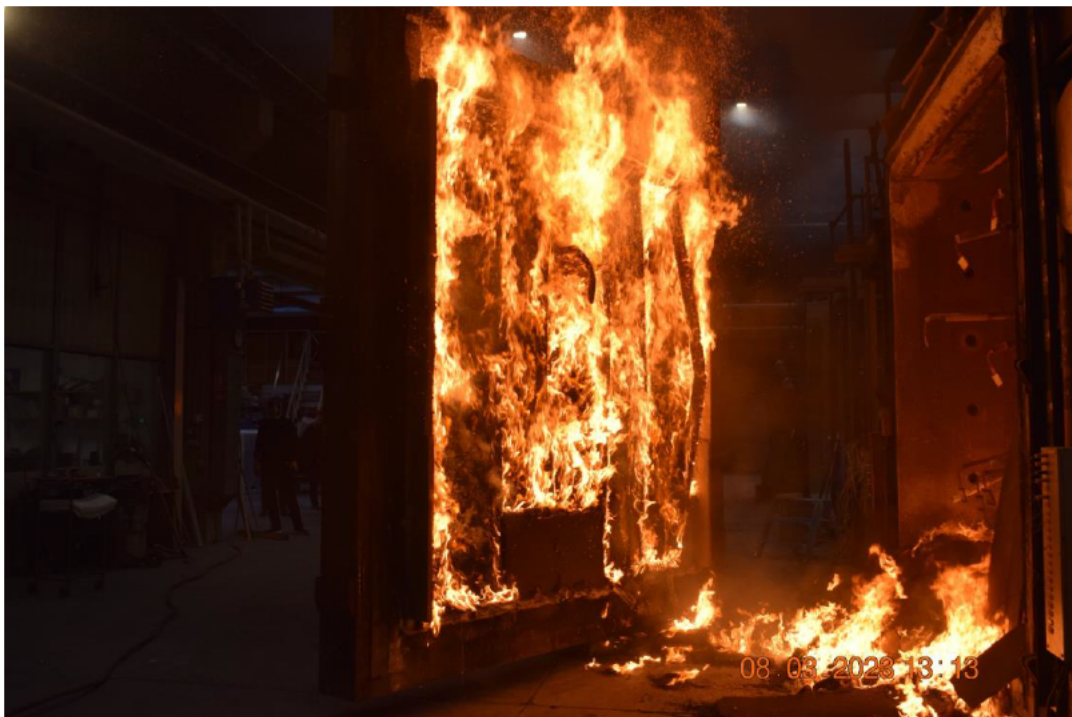
Photo No. 13 Test specimen seen from exposed side right after test
